Getting it Right: A Practical Guide to Addressing Key Issues in Reopened Sandy Claims and Flood Damage

This document addresses common estimating discrepancies found in estimates prepared by flood adjusters who have written, and are currently writing estimates for flood claims under the National Flood Insurance Program.

Jeffrey S. Major
June 19, 2015

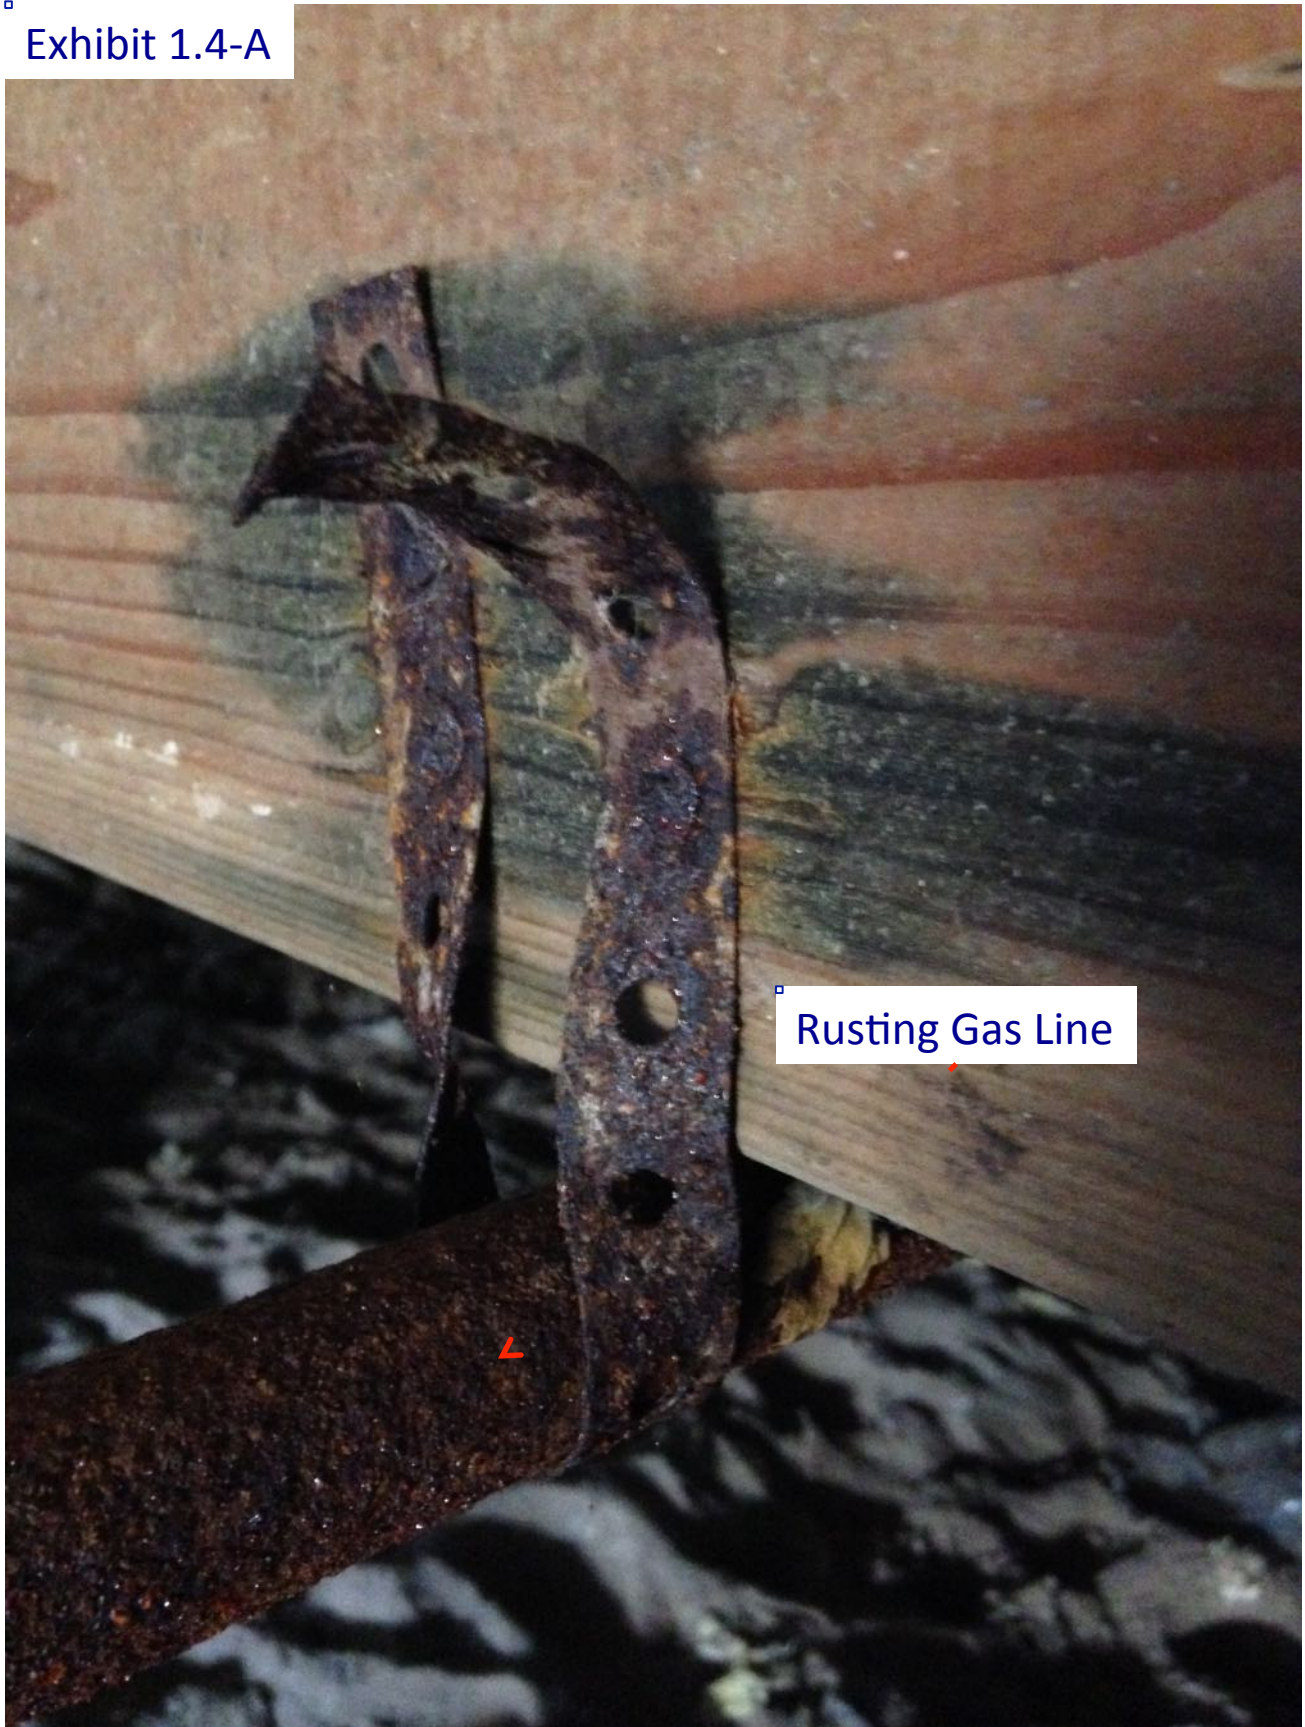
Exhibit 1.4-A

Gas service, piping, valves and lines to individual appliances and equipment have been omitted from most estimates. Currently, rough lines and valves that were exposed to salt water are continuing to rust and deteriorate. (see *exhibits 1.4-A, 1.4-B & 1.4-C*) Flexible gas lines to appliances were discarded with the appliances.

- 1.4-A** Photo. - Rusted gas line and hanger in a crawlspace post Sandy.
- 1.4-B** Photo. - Rusted gas line and corroding fitting in a crawlspace post Sandy.
- 1.4-C** Photos. C.1 & C.2 – Corroding and rusting gas manifold, fittings and flex gas lines in a crawlspace post Sandy.
- 1.4-D** Excerpt from photo page of estimate prepared for an insured – Depicting a gas range and the servicing flex gas line.
- 1.4-E** Excerpt from photo page of a carrier estimate – Depicting corroding rough gas lines in wall, a shut off valve, and a flex gas line that serviced the gas range.

b. Add a shut off valve, escutcheon and flex connecting line to all gas fed mechanicals and appliances that are already being replaced in the property. (Note: some service lines may come from above)

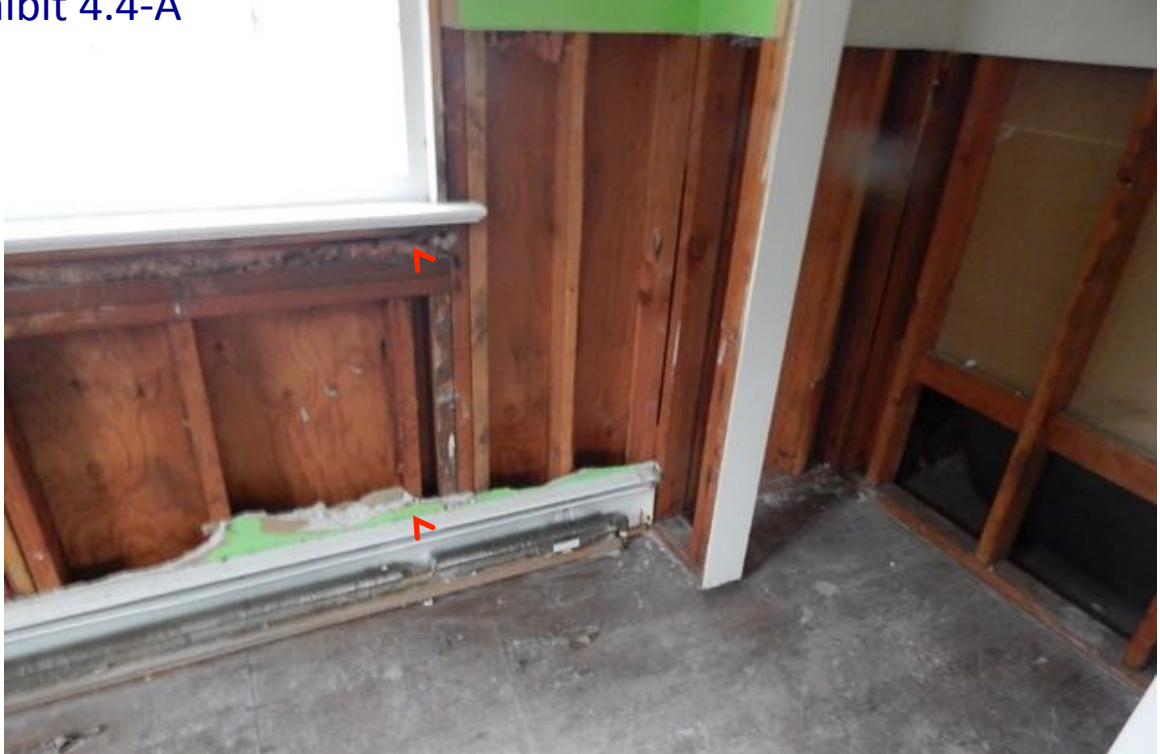
Exhibit 4.4-A

Post demo and remediation photo. Note drywall and insulation that was left behind. Allowances are still needed to prep for rebuild.

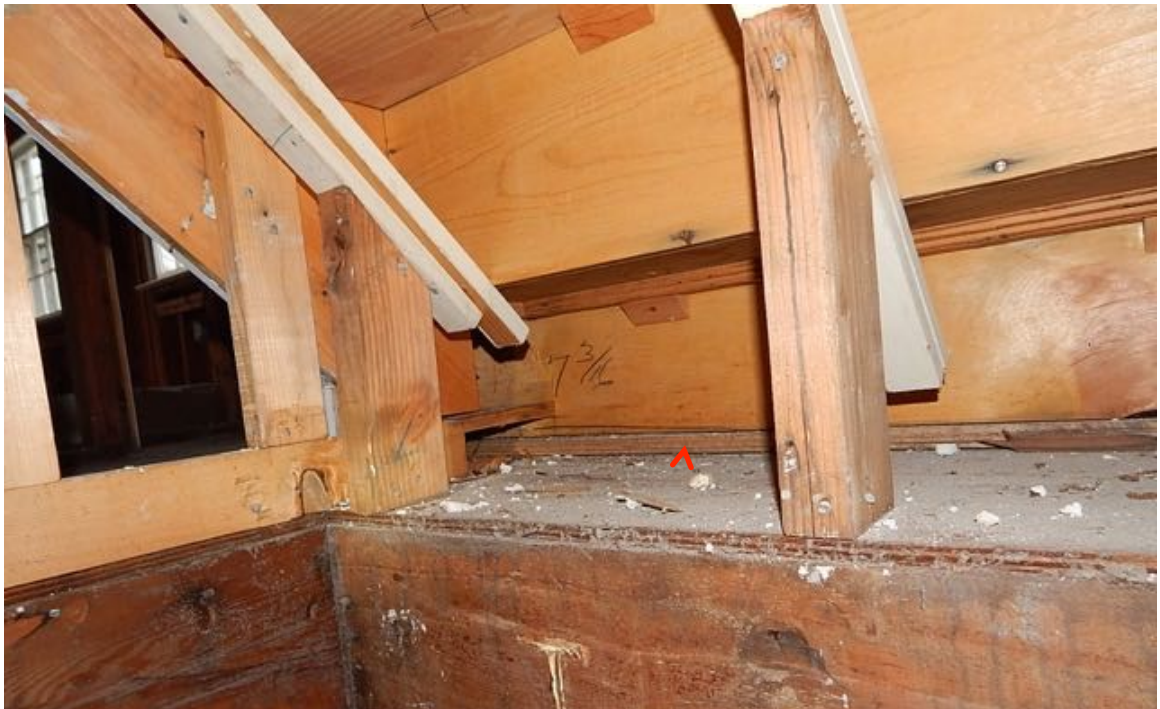
Post demo and remediation photo. Note T&G wood flooring that was left behind, as contractor did not want to remove finished flooring that the staircase was sitting on. Allowances are still needed to prep for rebuild.

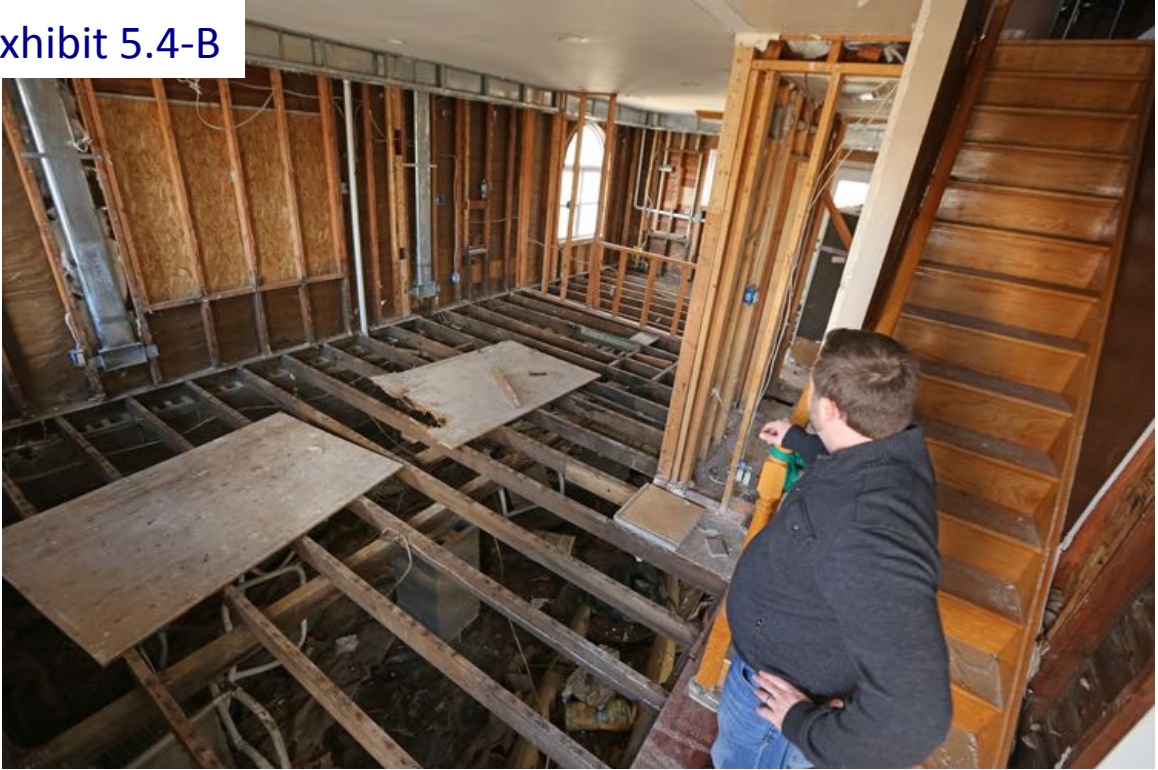
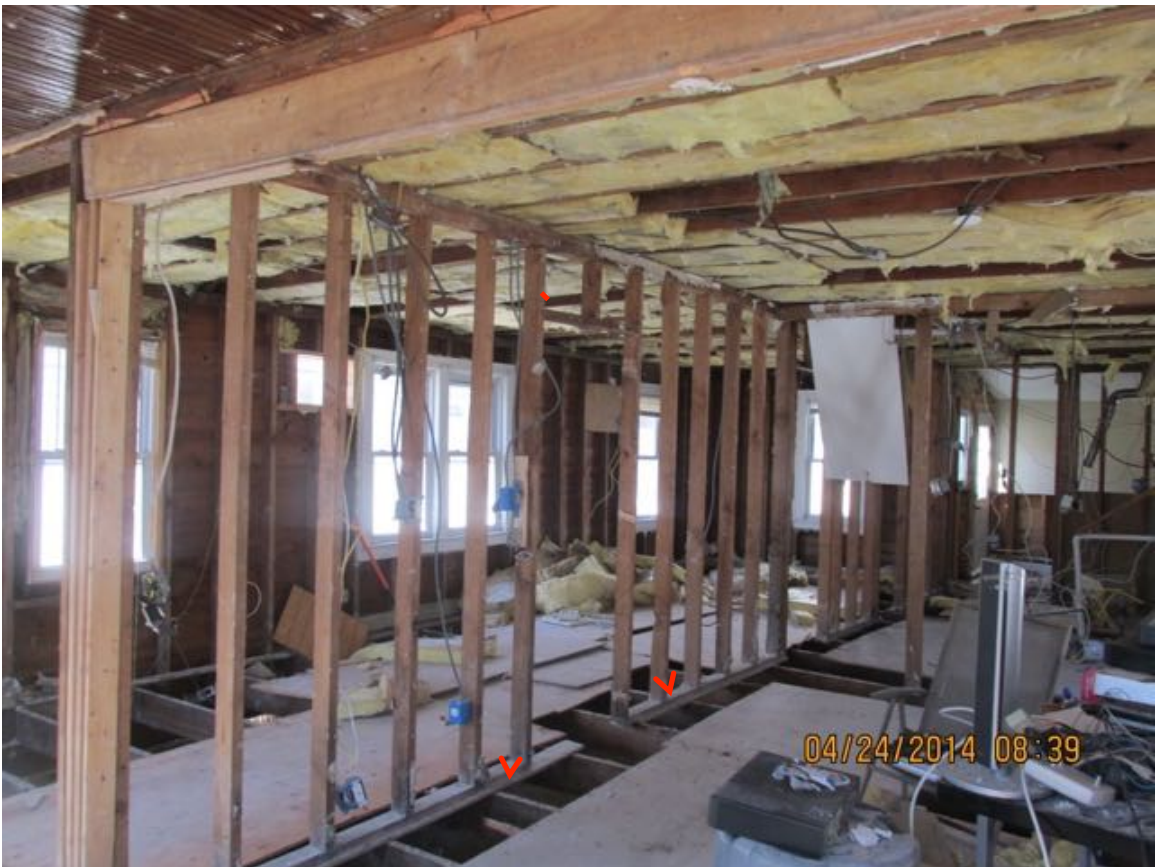
Exhibit 5.4-B

Sandy homes where subflooring was removed in easily accessible areas and not under walls or stairs. Note saw cuts along wall edge.

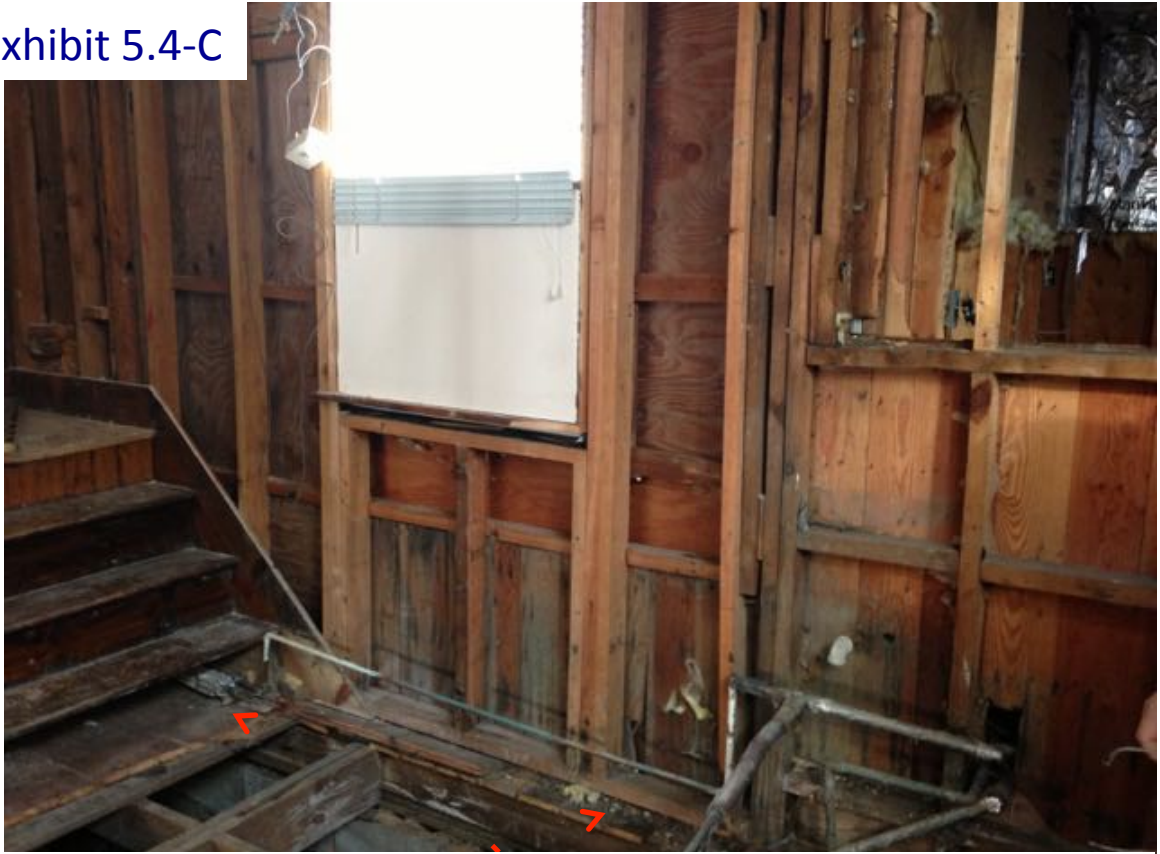
Exhibit 5.4-C

Remaining subflooring under the stairs and exterior walls

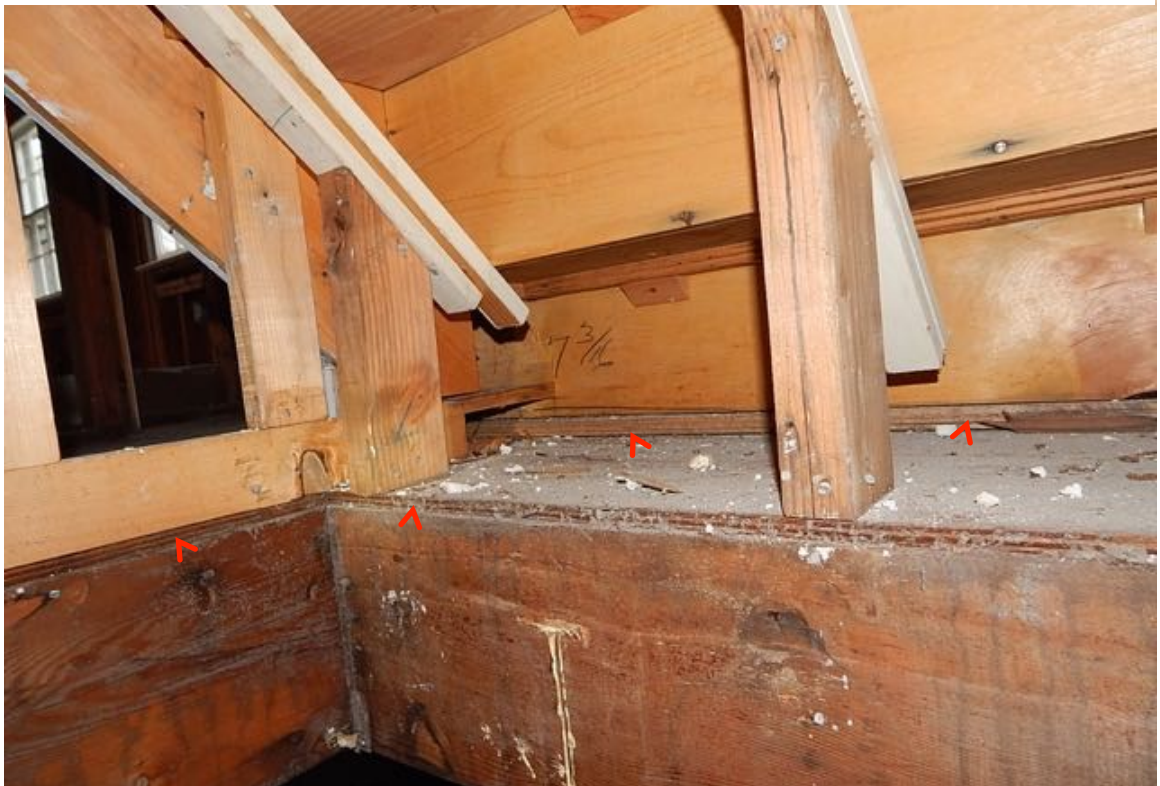
Remaining subflooring and finished hardwood under stairs

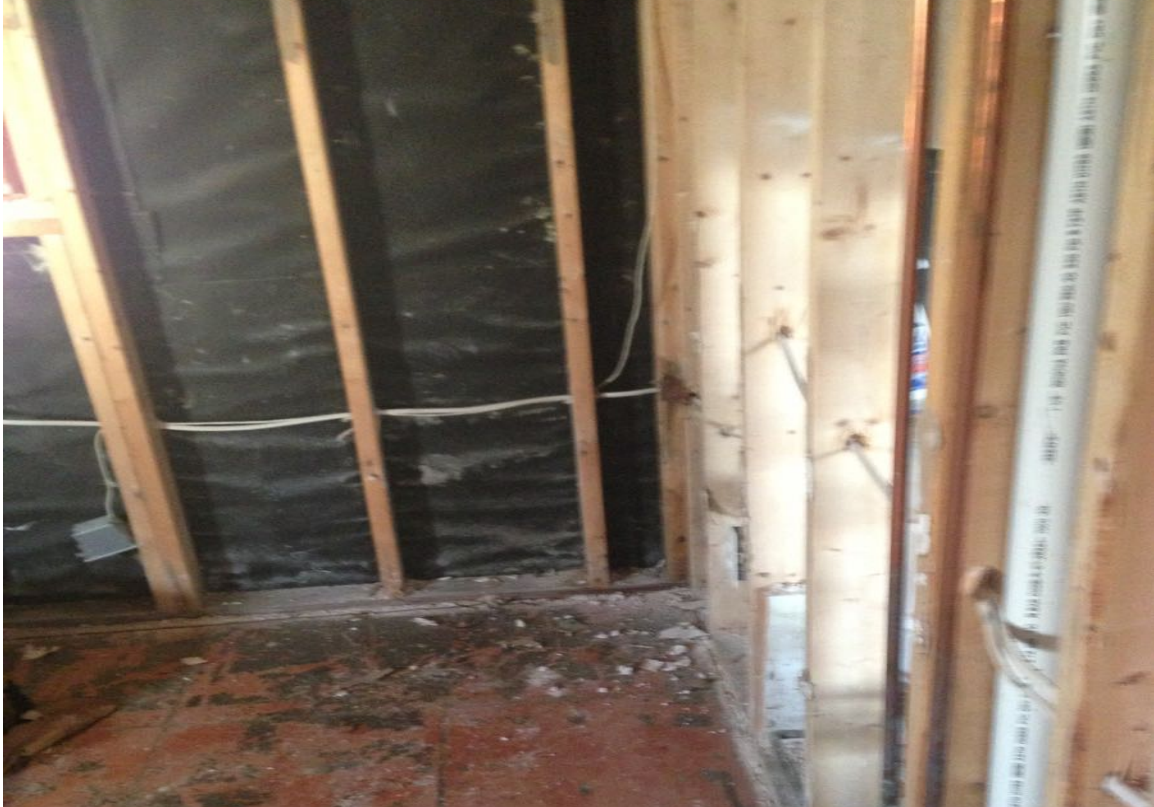
Exhibit 6.4-C

siding and vapor barrier. In some cases, (see exhibit 6.4-C) the interior side of the exterior sheathing is also lined with a tarpaper vapor barrier and drying is not effective unless you remove the additional vapor barrier. It is the siding, insulation, old siding layers and vapor barriers that keep the newly saturated sheathing from drying properly, resulting in rot.

A partially gutted home damaged by shows tar paper between the exterior wall framing and the exterior sheathing which would prevent drying efforts to reach the exterior sheathing.

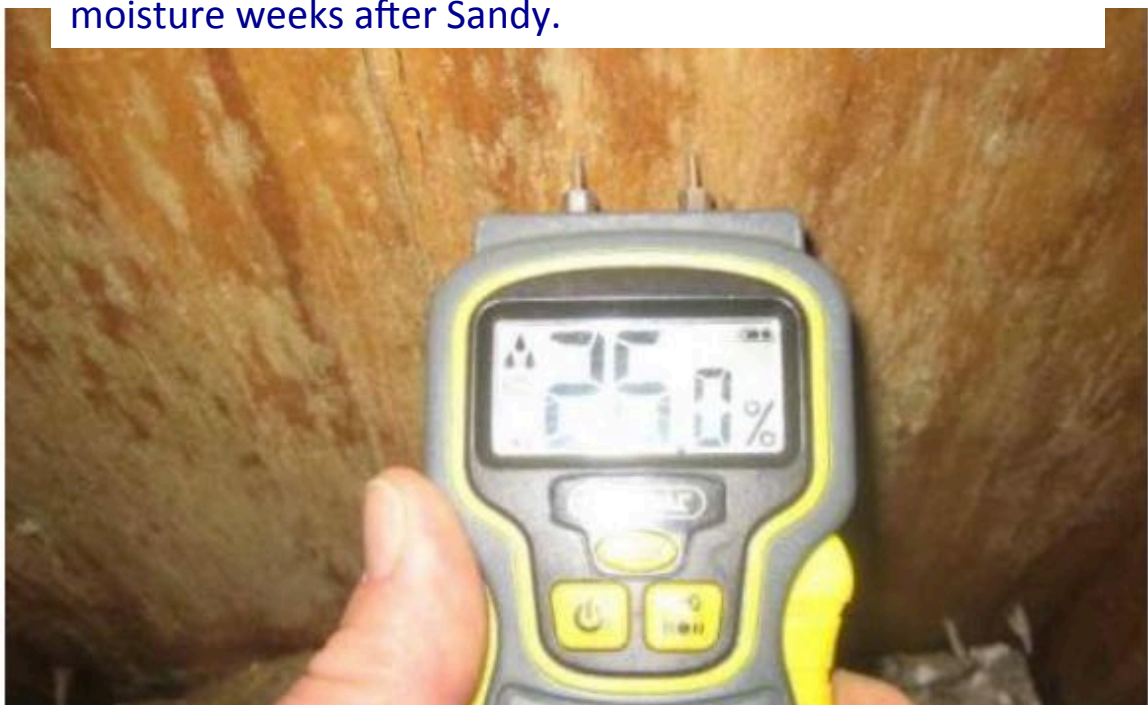
A separate home damaged by Sandy yielded high levels of moisture weeks after Sandy.

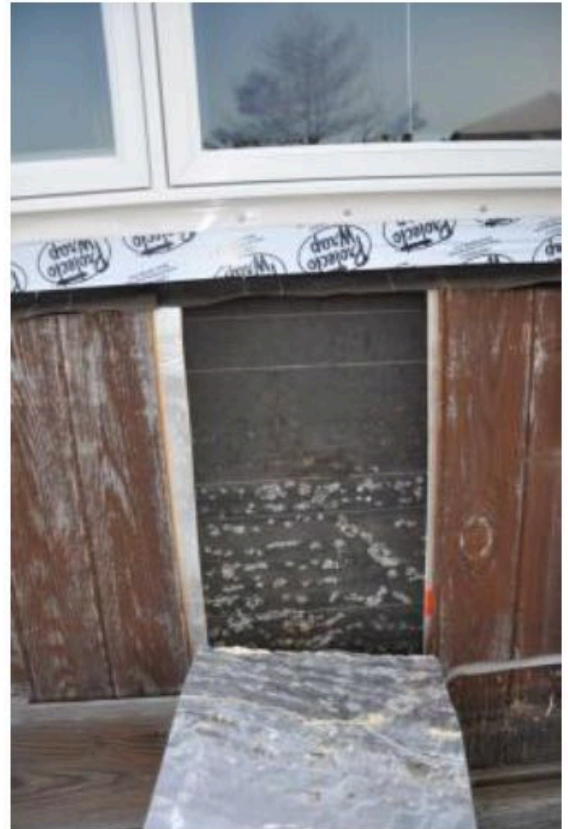
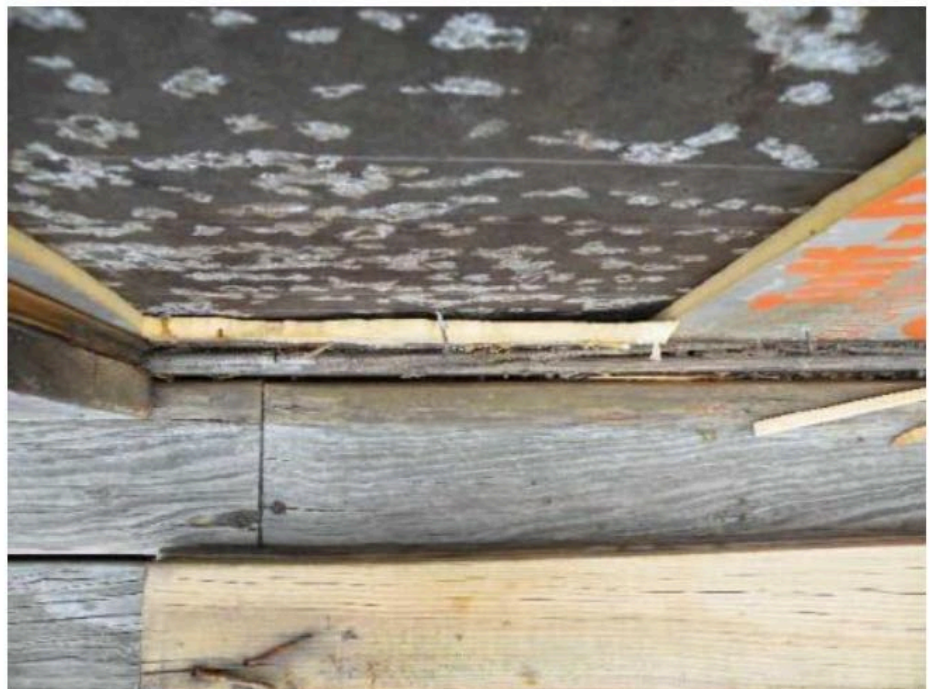
Exhibit 6.4-G

Microbial growth is present due water and moisture that was trapped between the multiple layers of building materials. Note: Vapor barriers such as house wrap, tar paper and facing on insulation are designed to prevent the pass thru of moisture.

When the cedar planks is removed the
tar paper has water damage

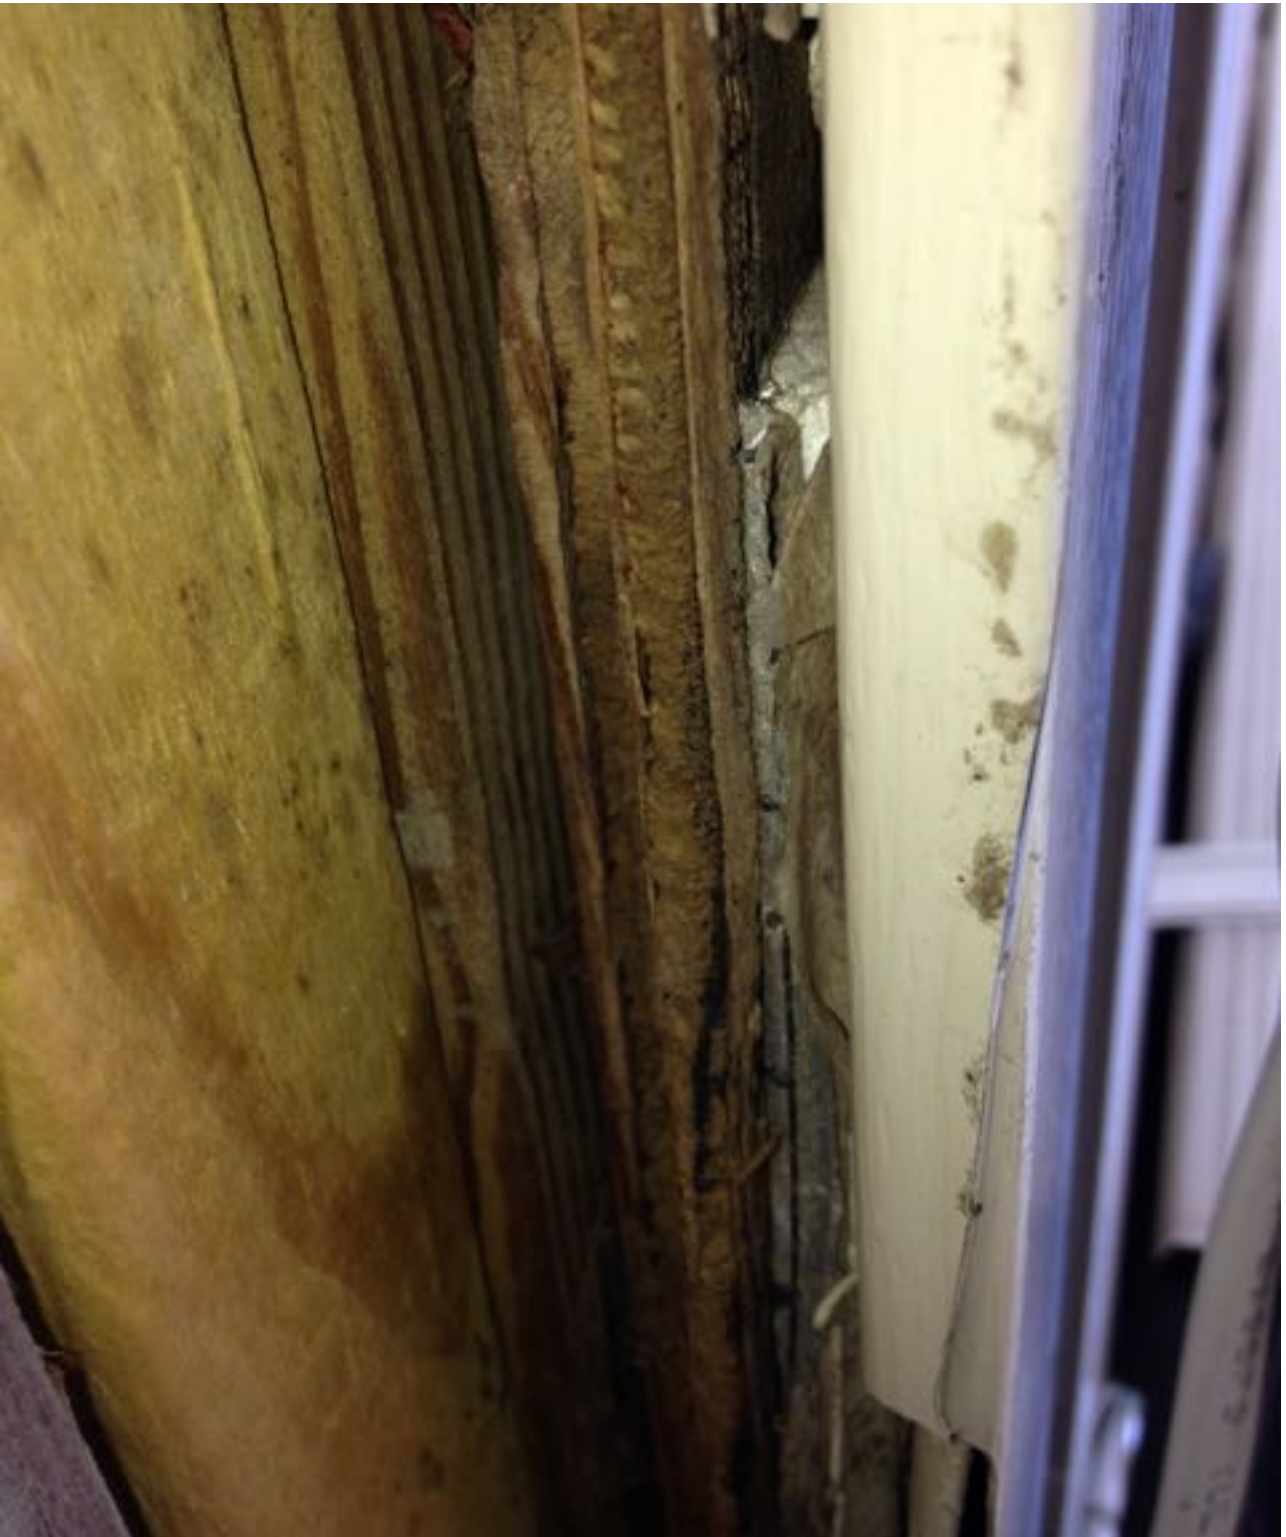
Exhibit 6.4-H

A photo of the layers of siding in a Breezy Point flooded home from Sandy. Note the multiple layers of siding, vapor barriers, insulation and sheathing behind the siding. A video of this home shows the siding to be disconnected from the rotted sheathing

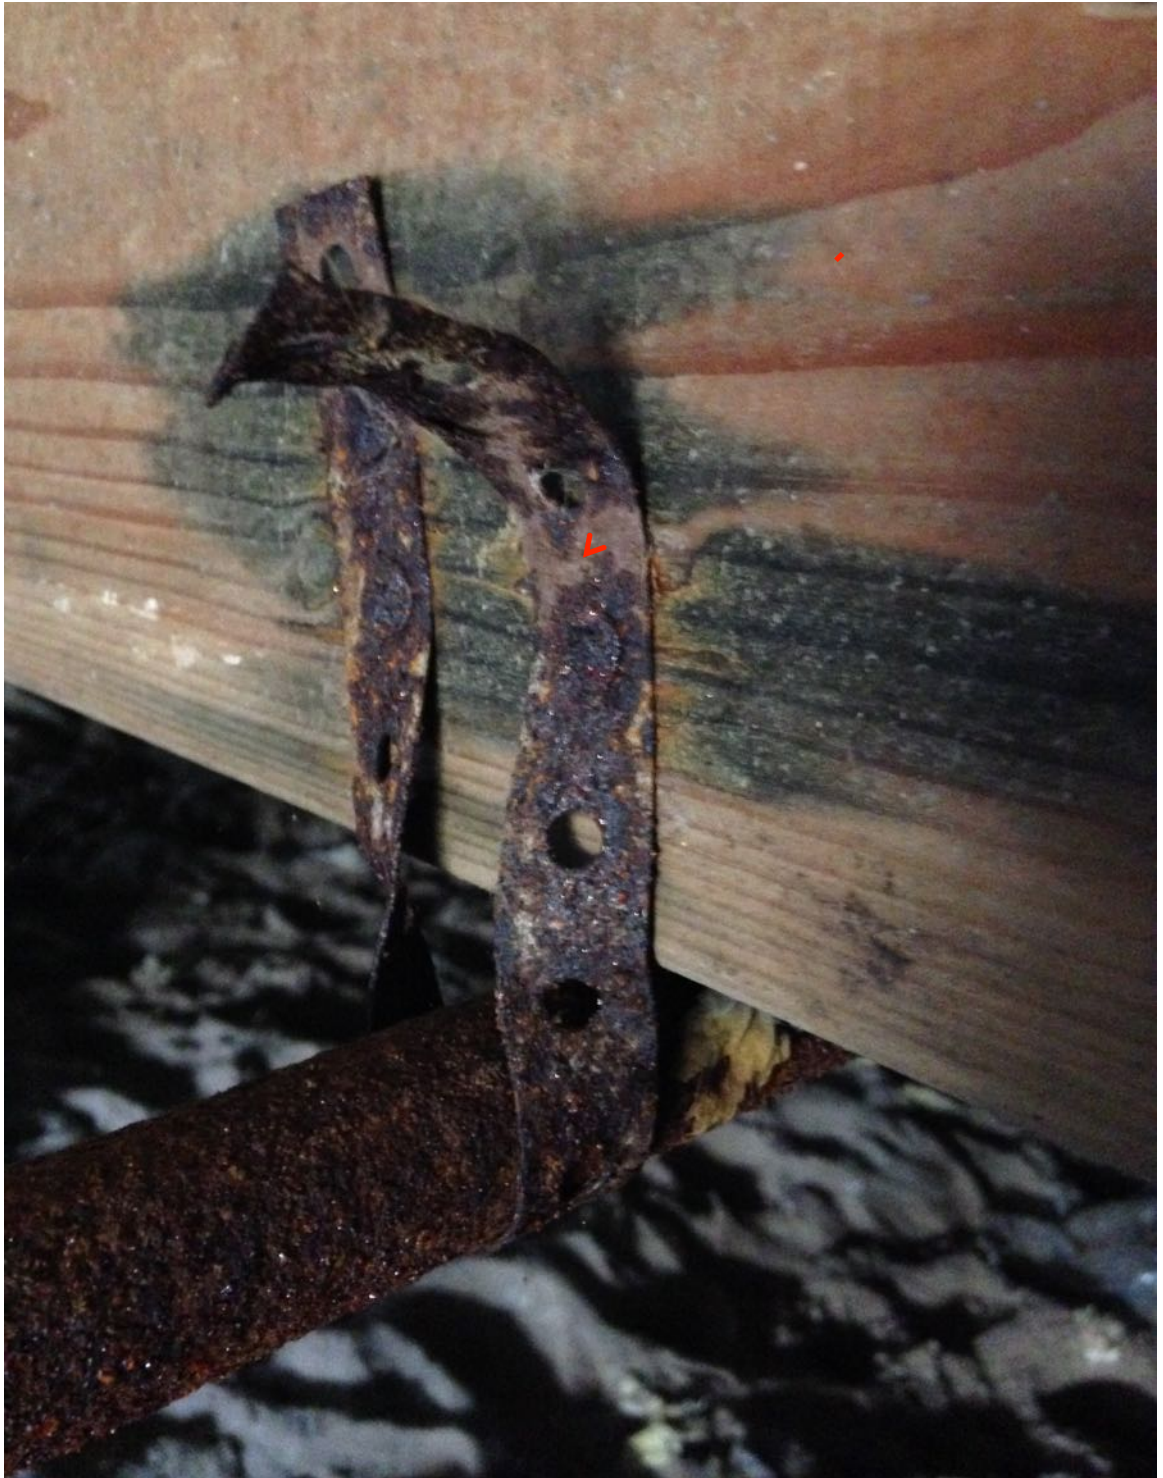
- Exhibit 7.4-A

- Metal hanger for a gas line in a post Sandy Breezy Point home. The claim was adjusted without consideration for the brackets.

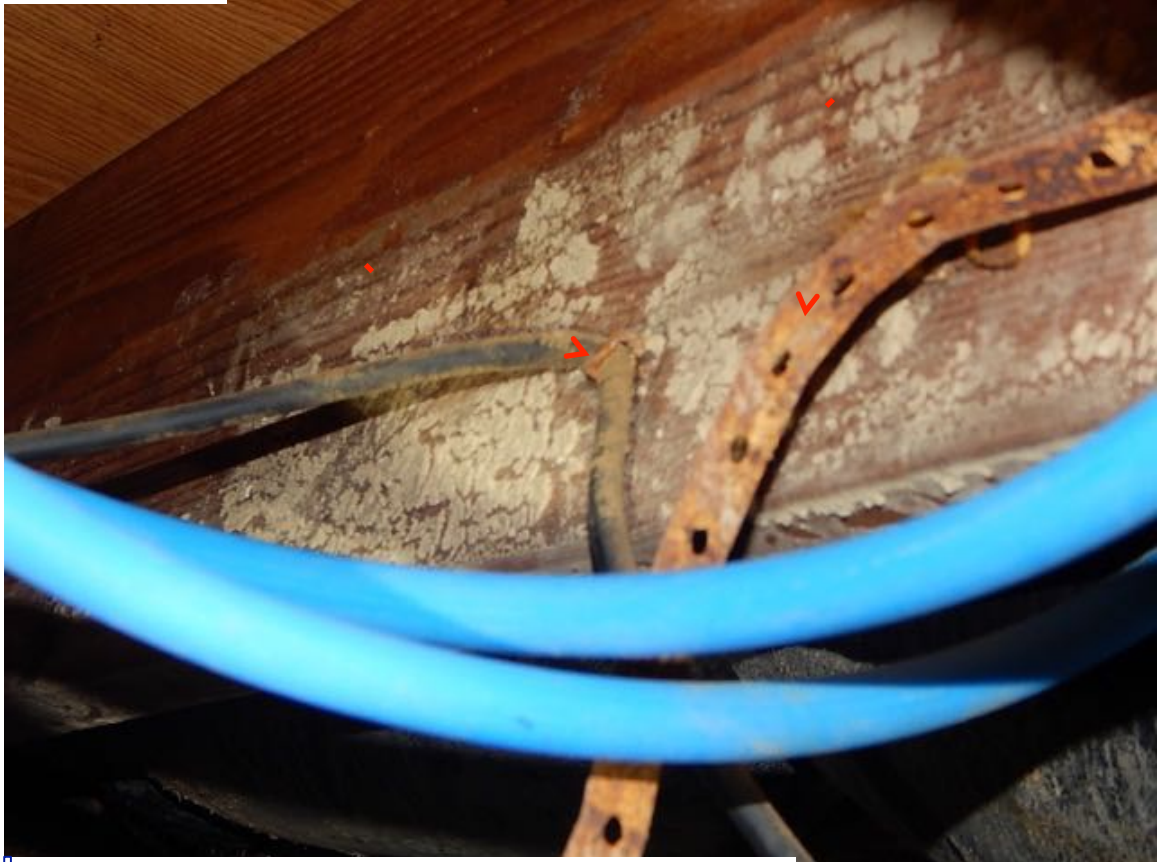
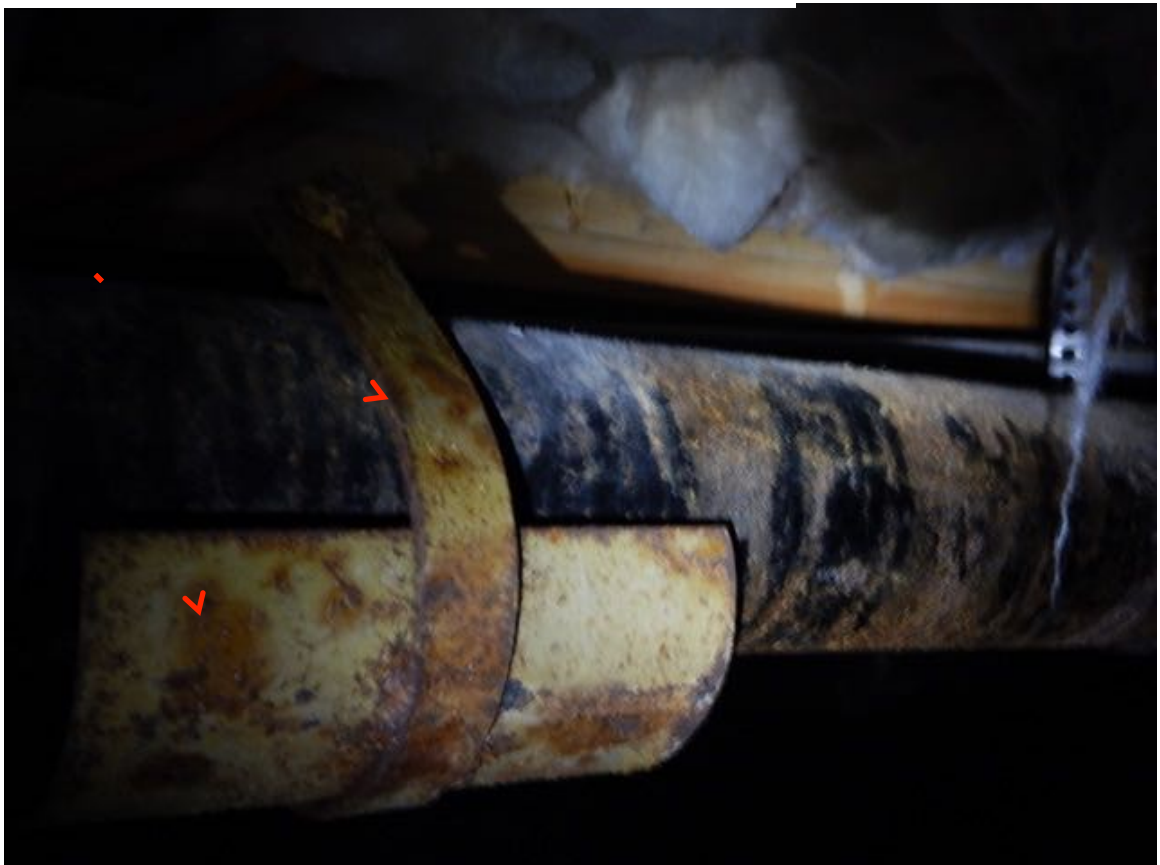
Exhibit 7.4-B

Rusted Brackets, staples and hangers.

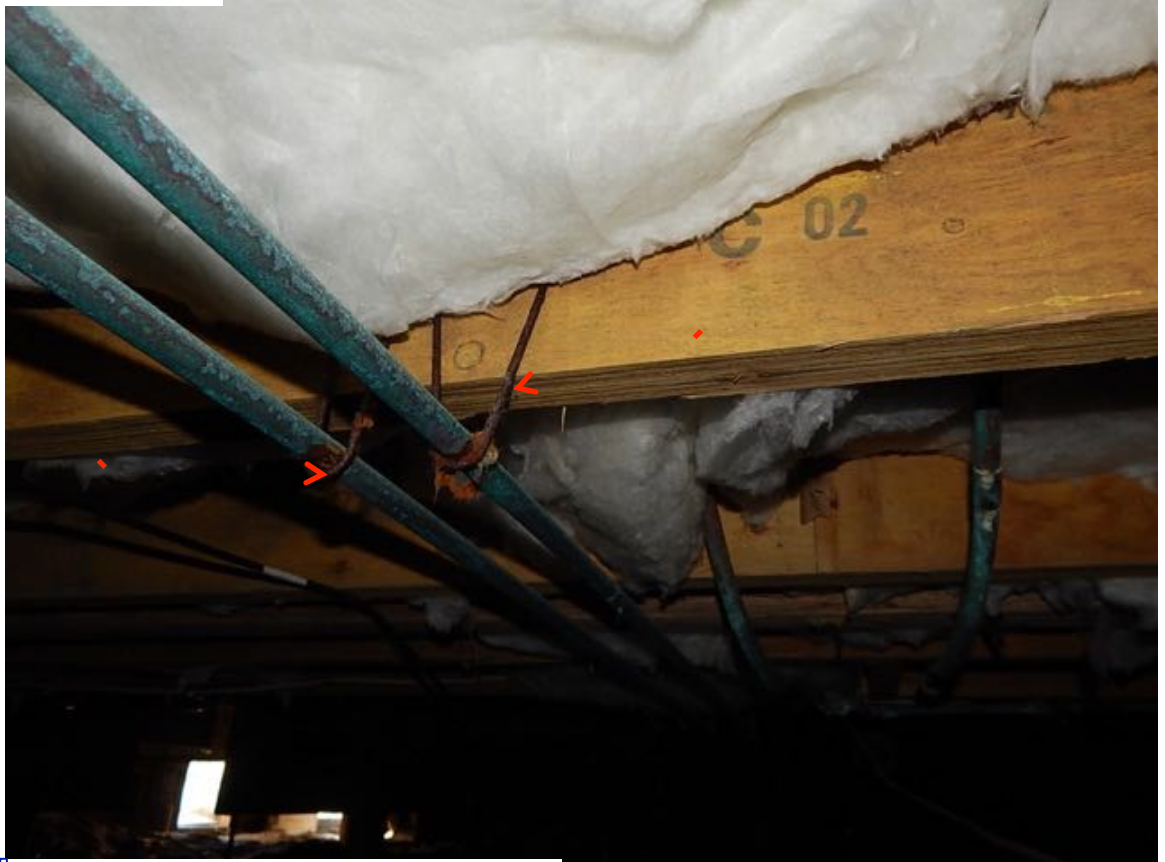
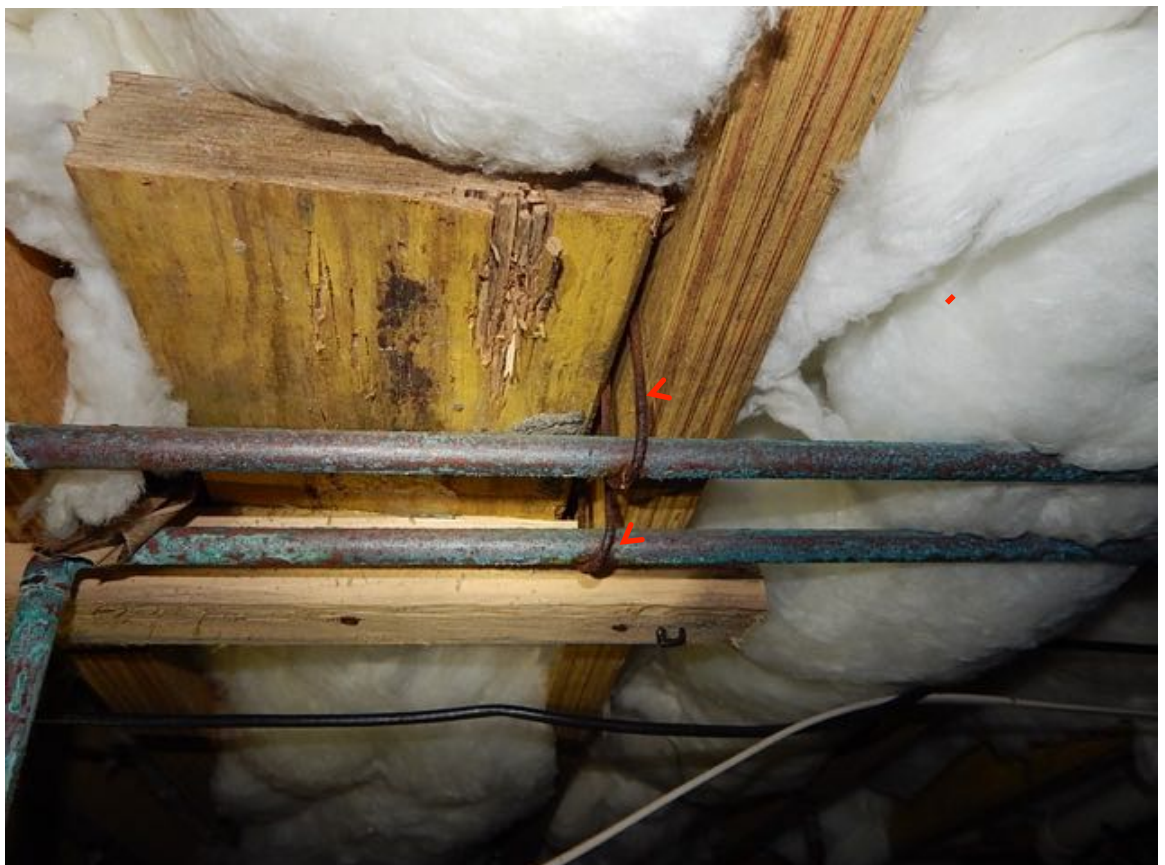
Exhibit 7.4-C

Rusted wire pipe hangers.

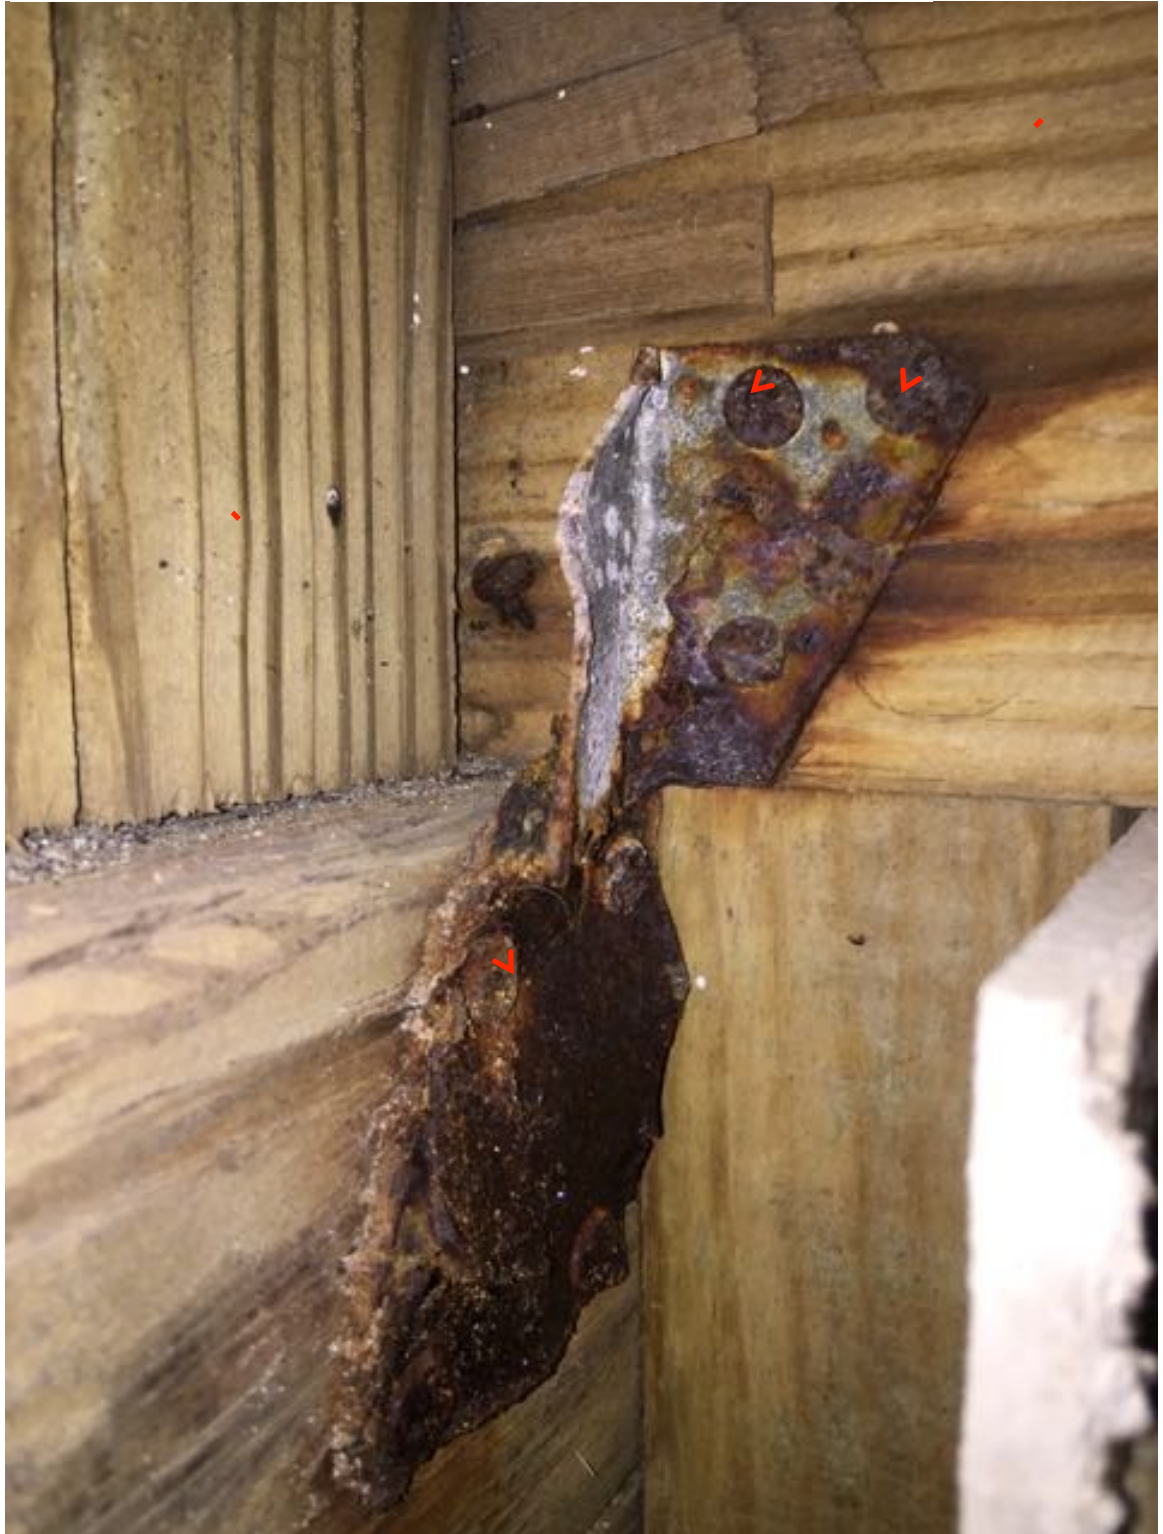
Exhibit 7.4-D

- Rusted Simpson strong tie bracket and nails.

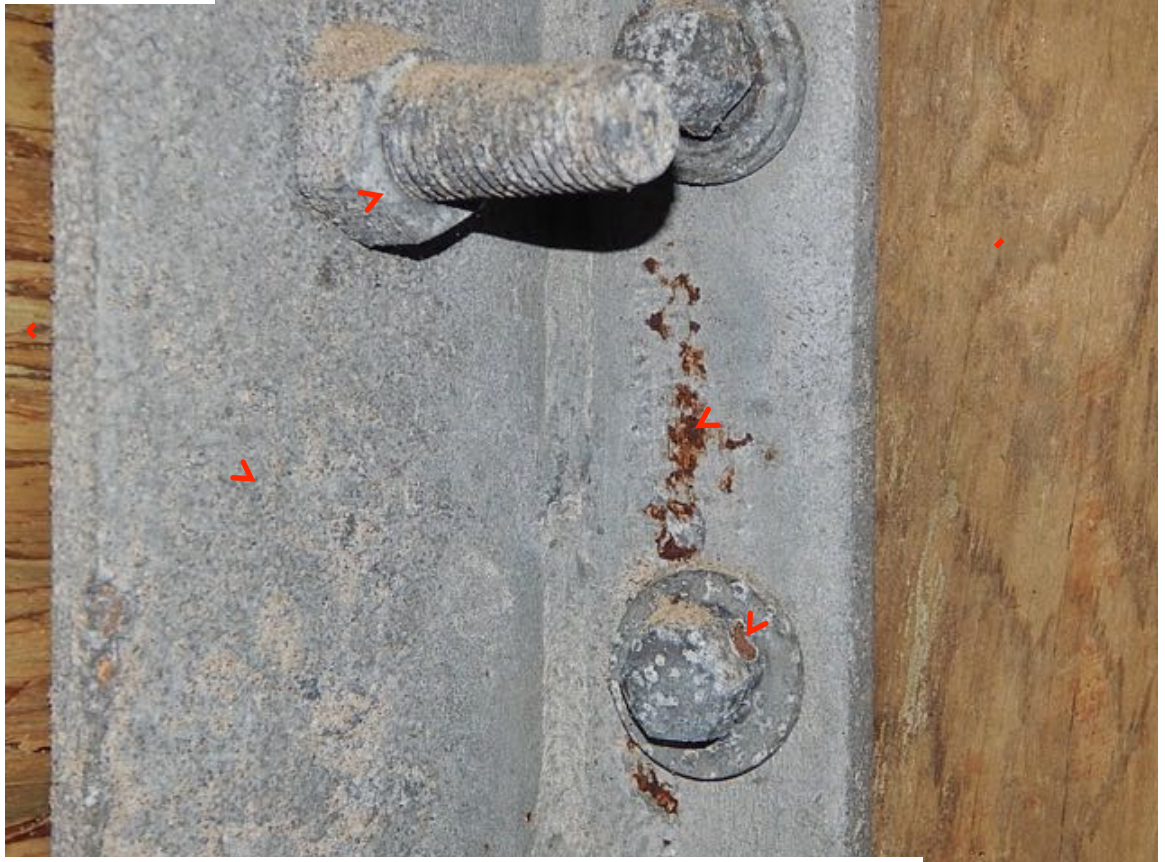
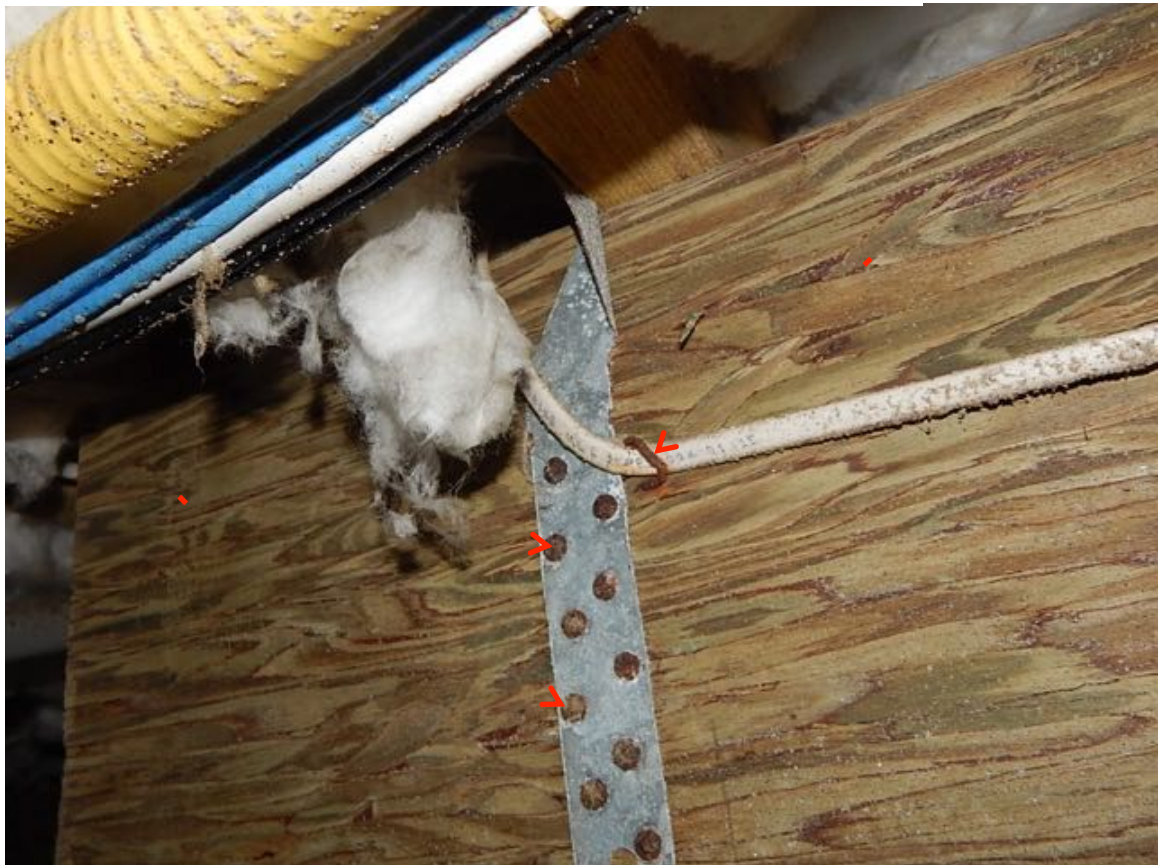
Exhibit 7.4-E

Corroding and rusting angle and rusting nails.
