Getting it Right: A Practical Guide to Addressing Key Issues in Reopened Sandy Claims and Flood Damage

This document addresses common estimating discrepancies found in estimates prepared by flood adjusters who have written, and are currently writing estimates for flood claims under the National Flood Insurance Program.

Jeffrey S. Major
June 19, 2015

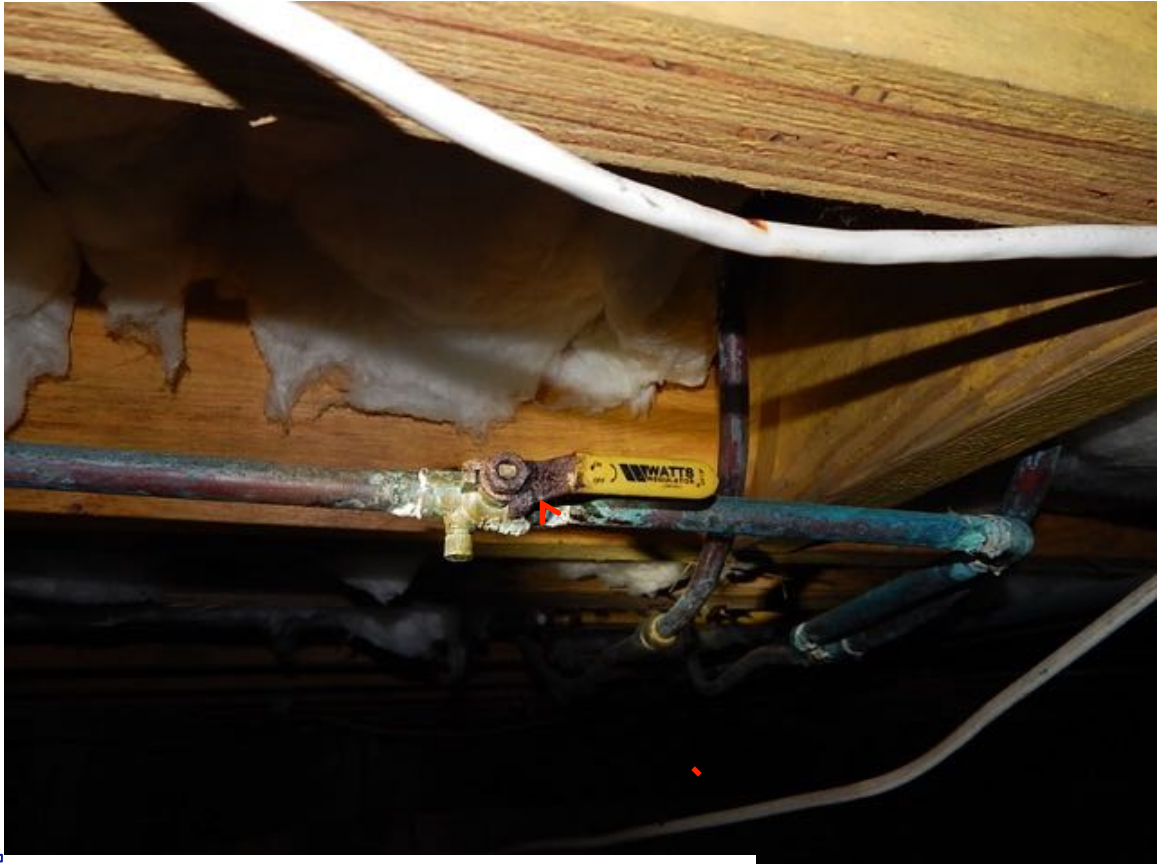
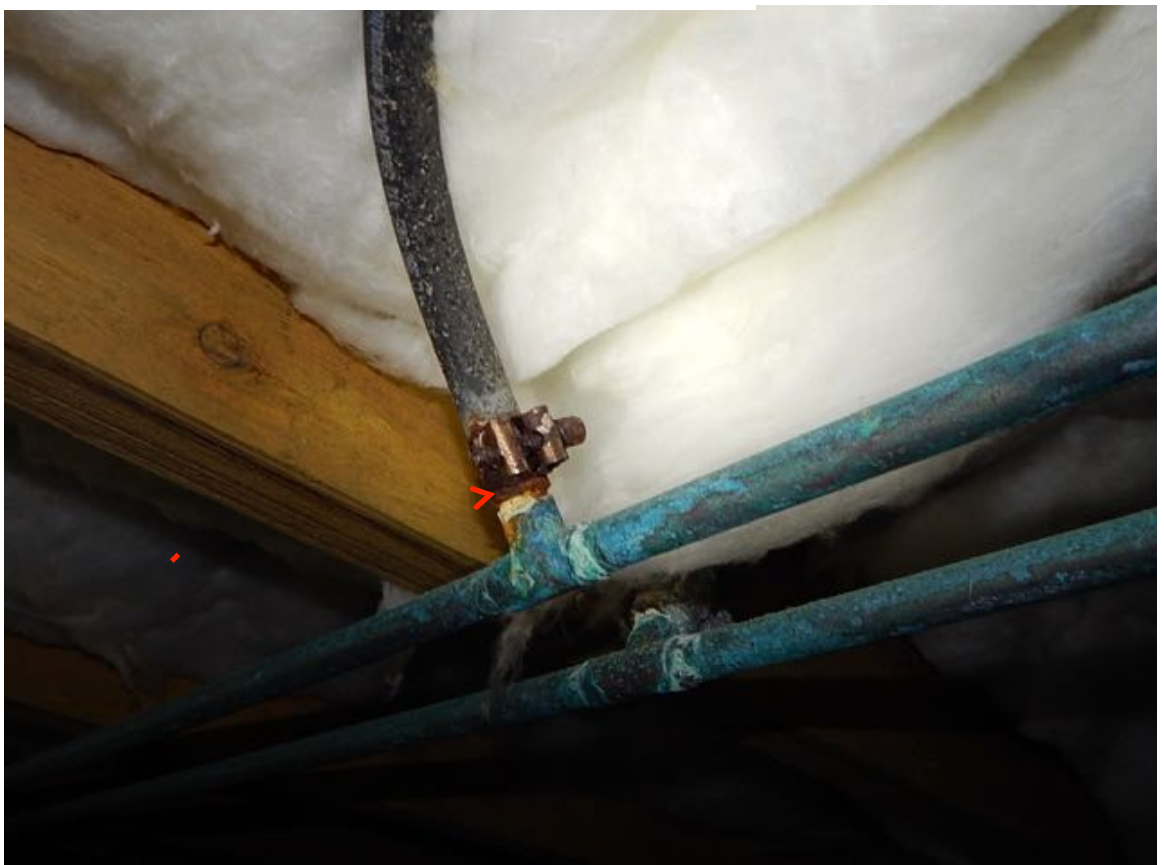
Exhibit 7.4-F

Rusted shut off valve and line clamp.

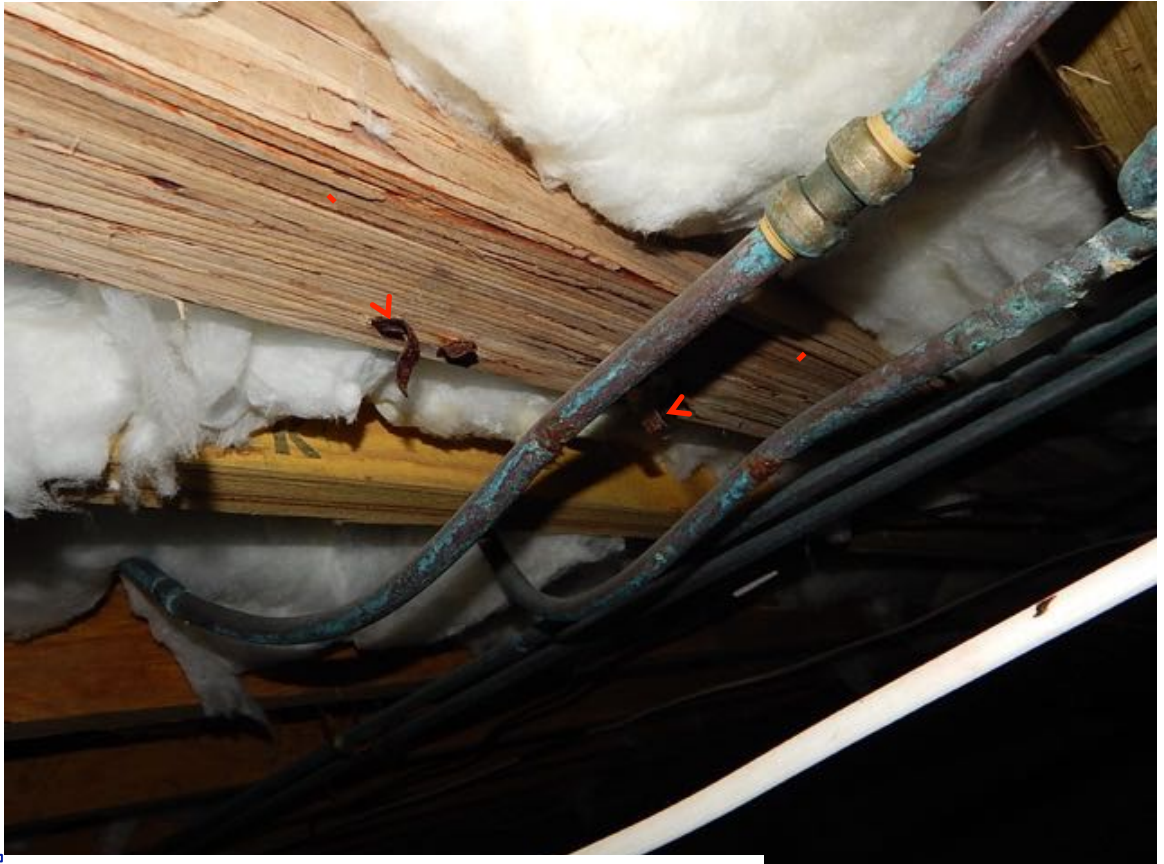
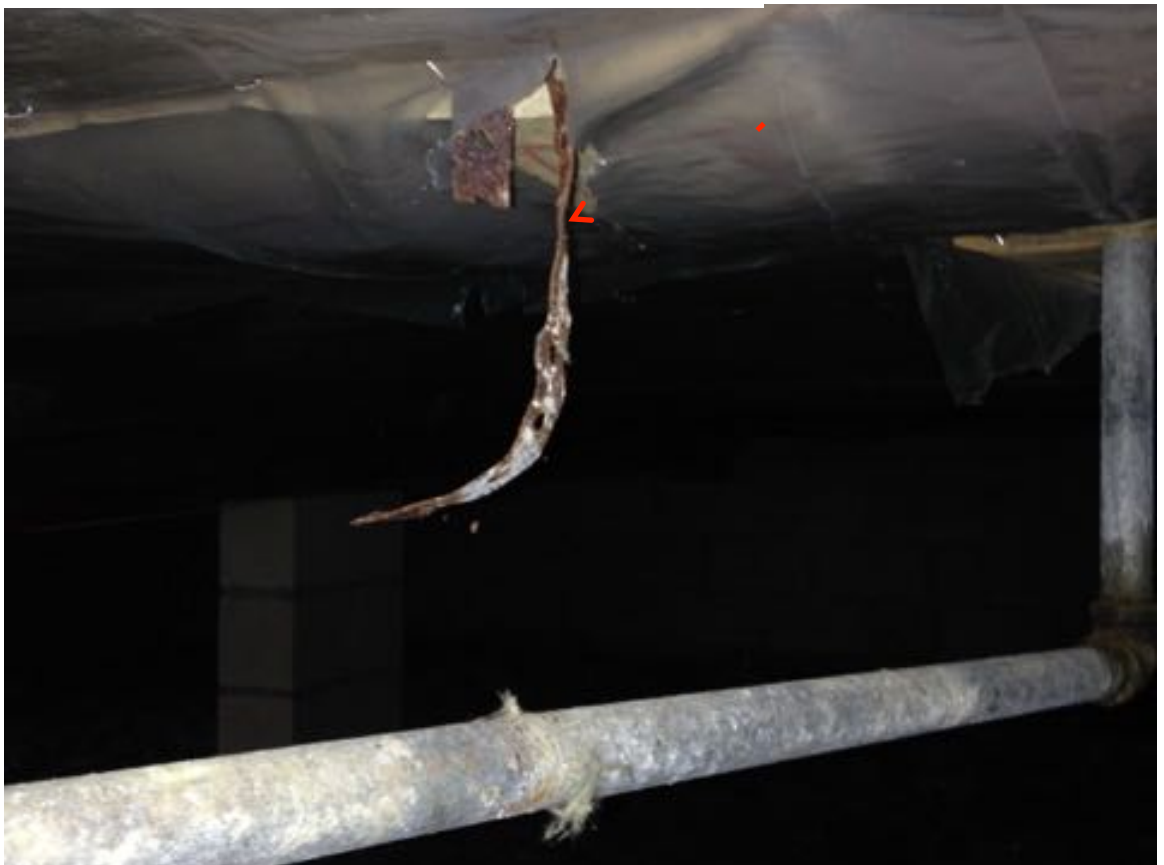
Exhibit 7.4-G

Rusted and failed brackets and strap.

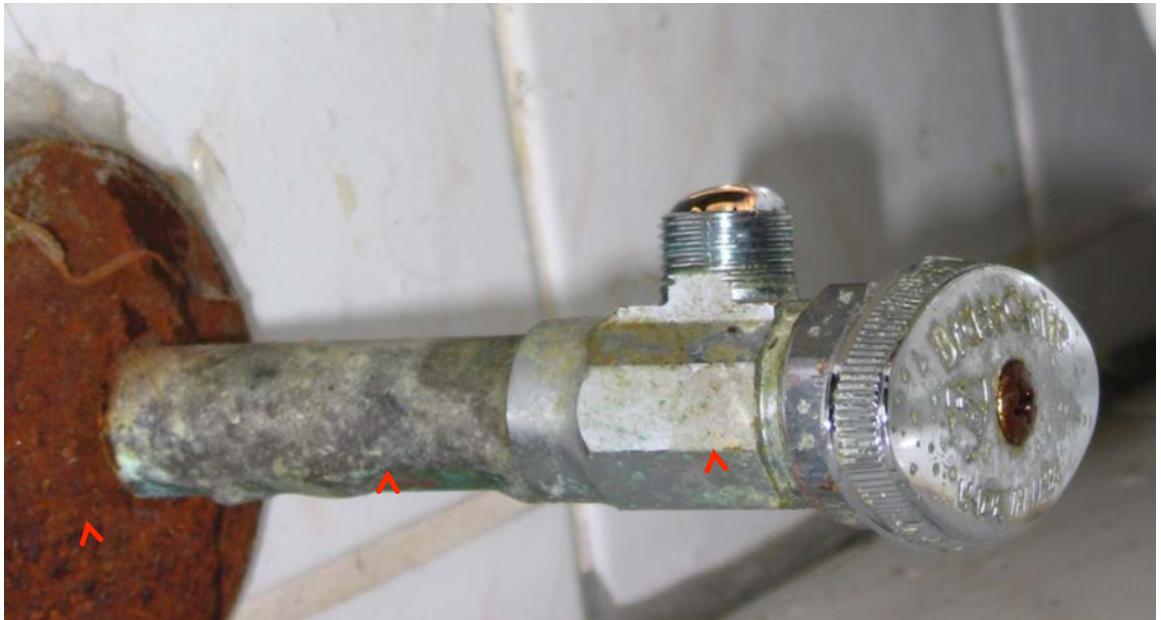
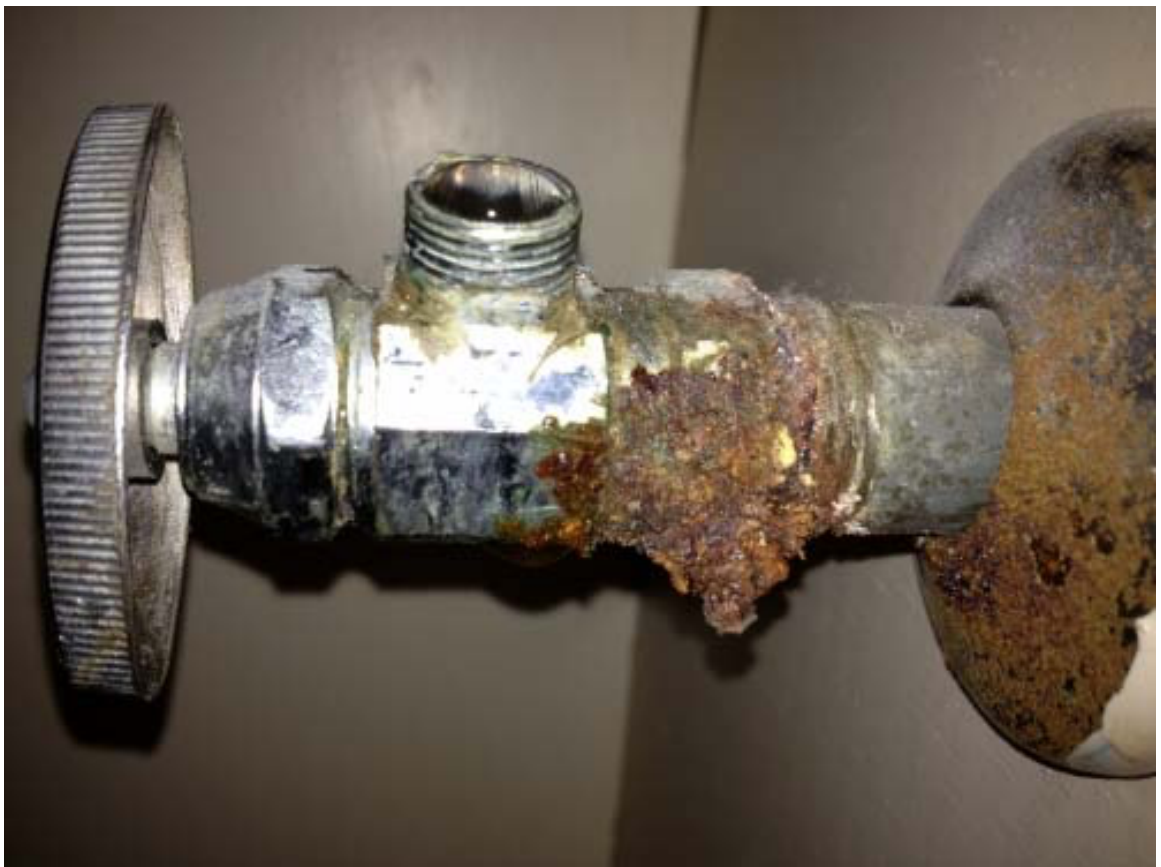
Exhibit 11.4-A

Escutcheon, Rough Pipe and Angle Stop Valve

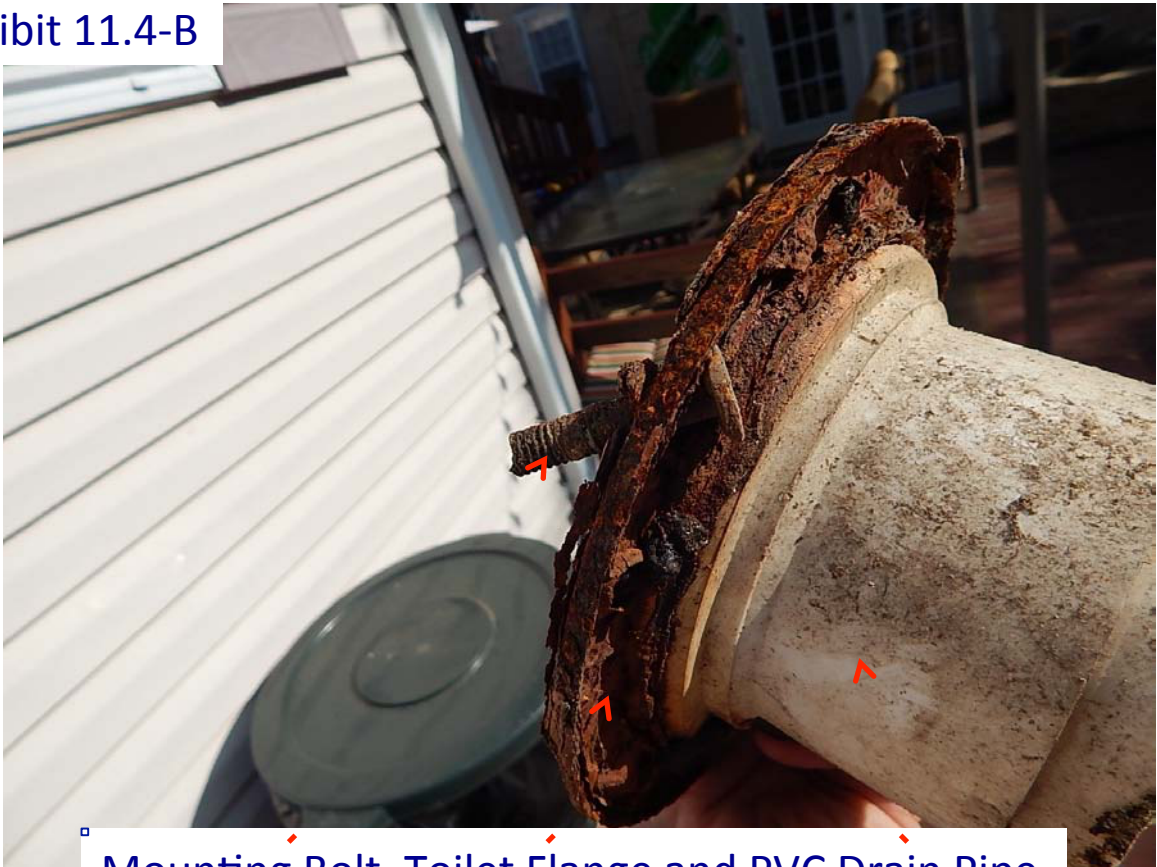
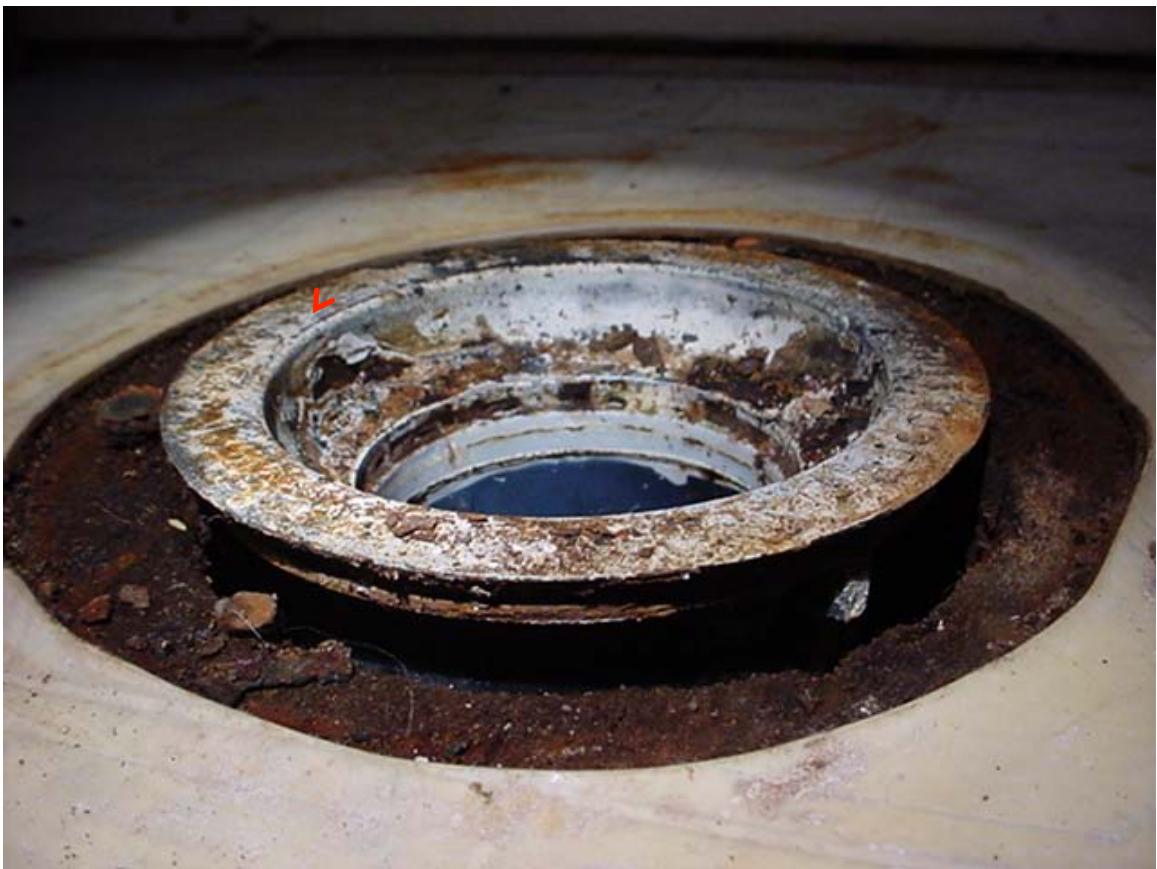
Exhibit 11.4-B

11.4-B Photos – Depicting rusted toilet flanges.

Mounting Bolt, Toilet Flange and PVC Drain Pipe

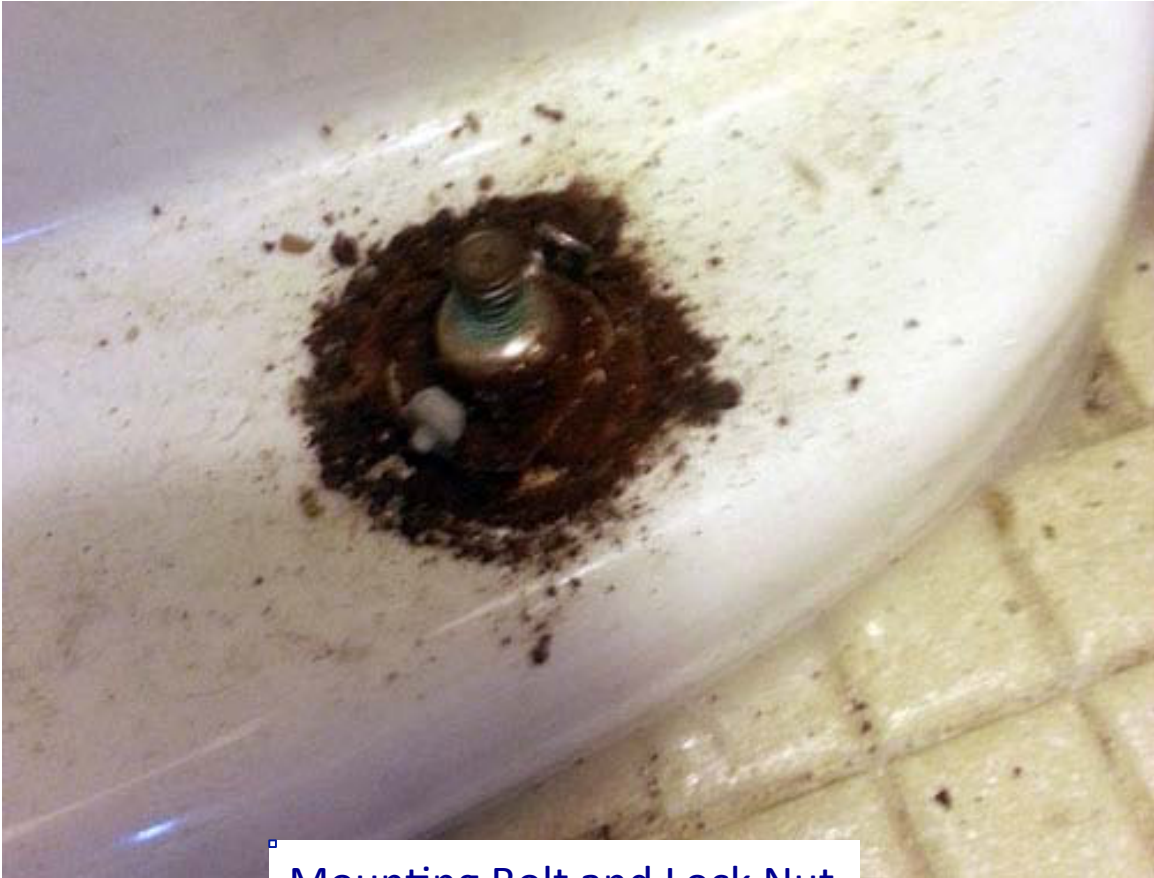
Exhibit 11.4-C

Mounting Bolt and Lock Nut
