Getting it Right: A Practical Guide to Addressing Key Issues in Reopened Sandy Claims and Flood Damage

This document addresses common estimating discrepancies found in estimates prepared by flood adjusters who have written, and are currently writing estimates for flood claims under the National Flood Insurance Program.

Jeffrey S. Major
June 19, 2015

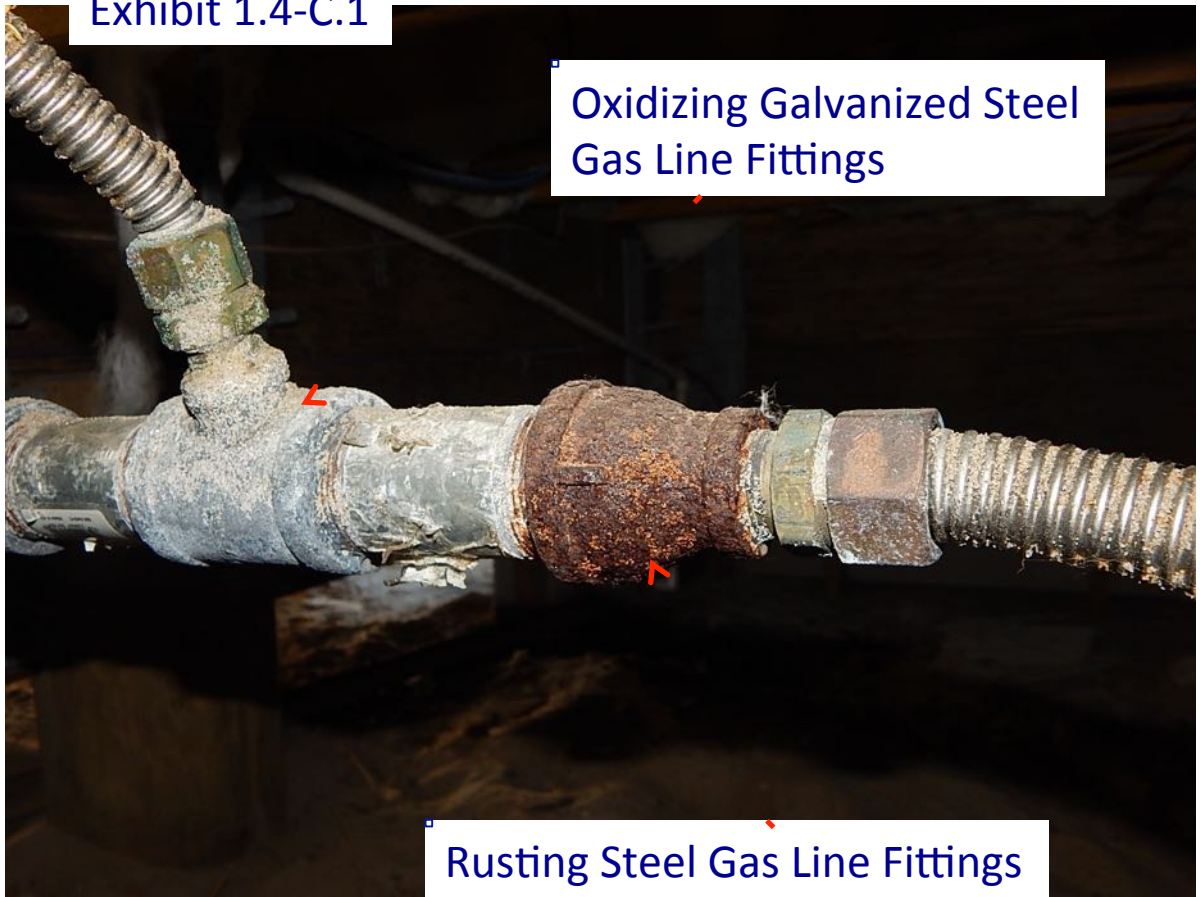
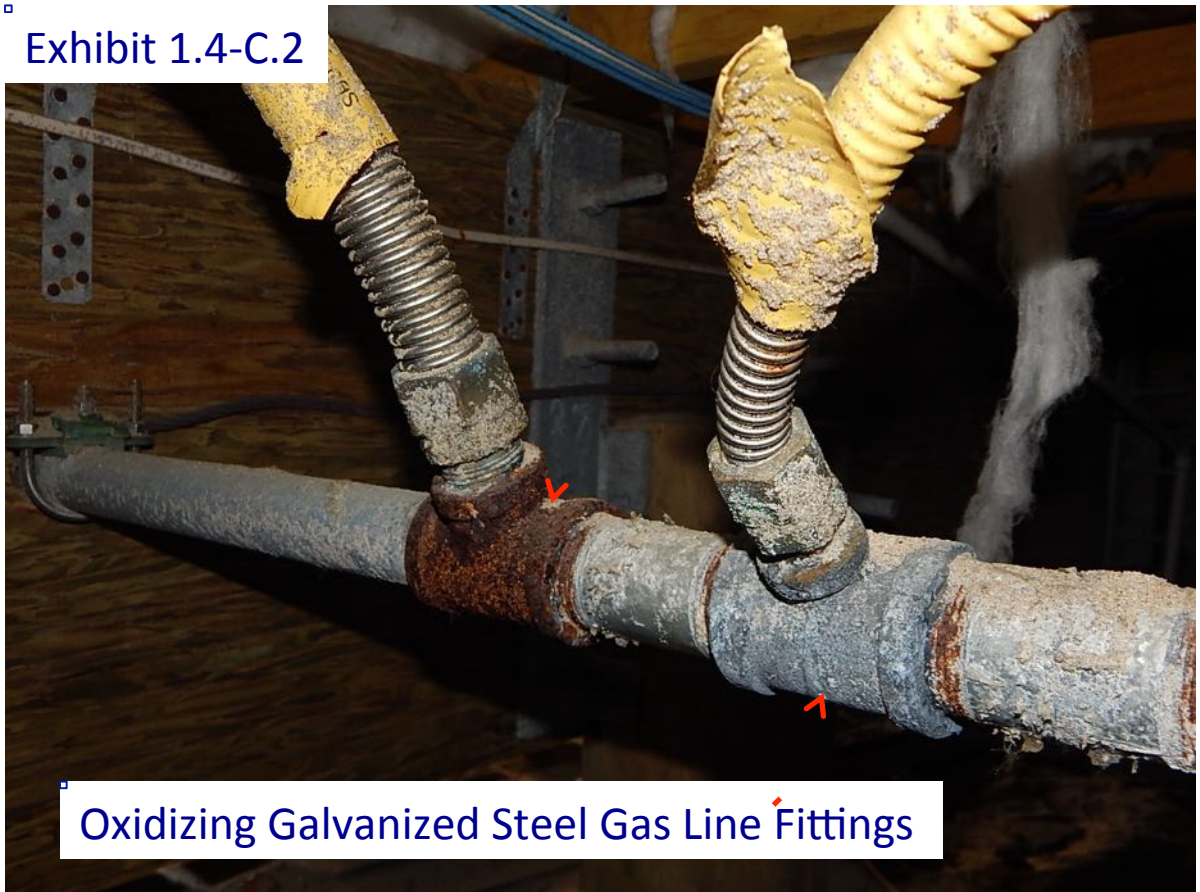
Exhibit 1.4-C.1

Gas service, piping, valves and lines to individual appliances and equipment have been omitted from most estimates. Currently, rough lines and valves that were exposed to salt water are continuing to rust and deteriorate. (see *exhibits 1.4-A, 1.4-B & 1.4-C*) Flexible gas lines to appliances were discarded with the appliances.

Rusting Gas Line

Include this issue in the protocol for claims review, identify the presence of gas service to the property and calculate costs for payment to the insureds.

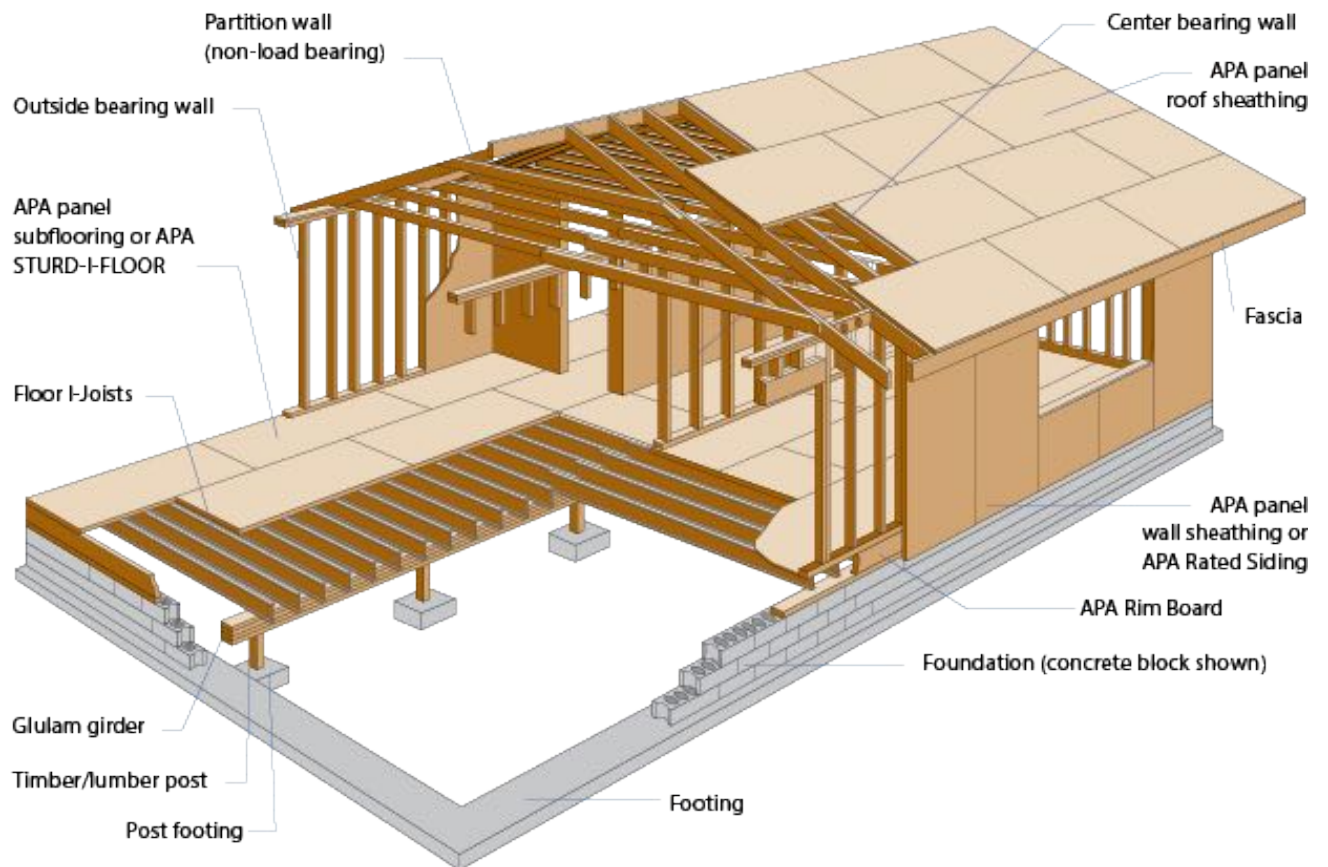
Exhibit 5.4-A

- 5.4-A** Detail – Depicting the anatomy of a platform constructed home.
- 5.4-B** Photos – Showing post Sandy homes with partial subflooring removed.
- 5.4-C** Photos – Showing a post Sandy (top) and a non-Sandy home with stairs on top of subflooring and finished floor.
- 5.4-D** Excerpt – From a supplemental IA estimate (NFS approved) adding an allowance for subflooring under walls.
- 5.4-E** Excerpt – From an estimate detailing actual costs for replacing full subflooring in a house entered into individual line items in Xactimate.

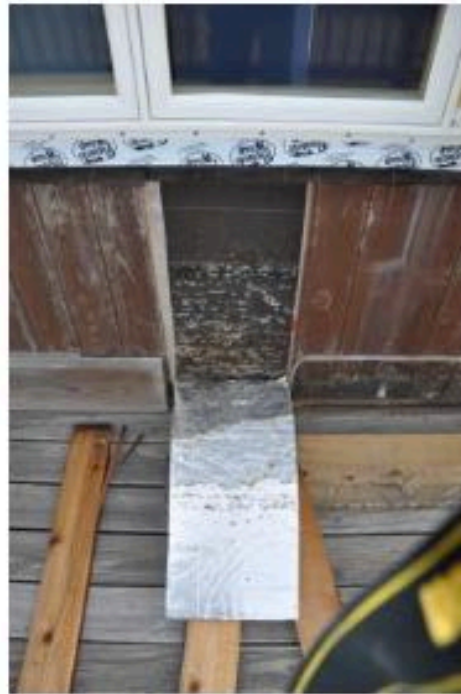
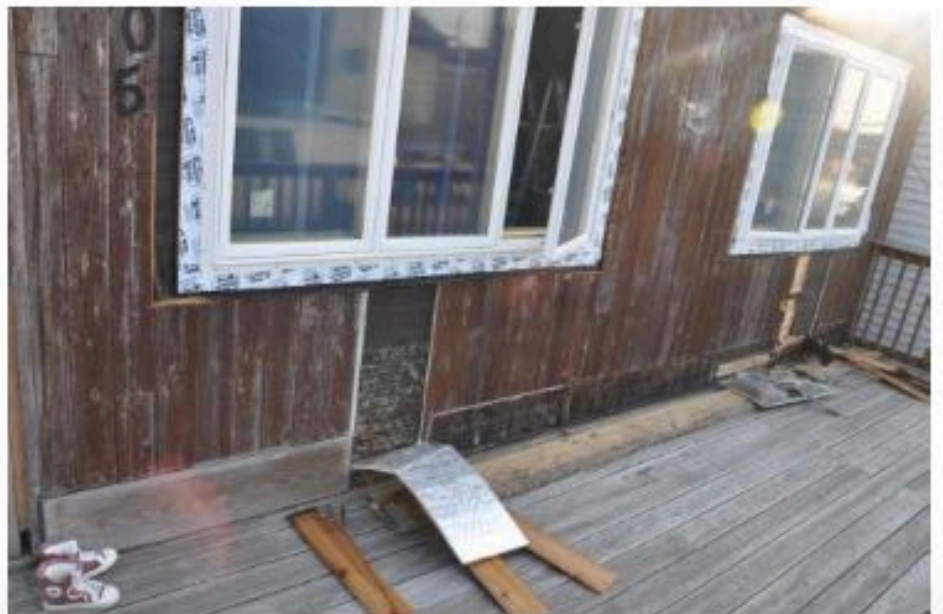
An excerpt from an estimate prepared for the insured depicts the building components behind the siding and the direct physical damage caused by flood.

Microbial growth is present due water and moisture that was trapped between the multiple layers of building materials. Note: Vapor barriers such as house wrap, tar paper and facing on insulation are designed to prevent the pass thru of moisture.

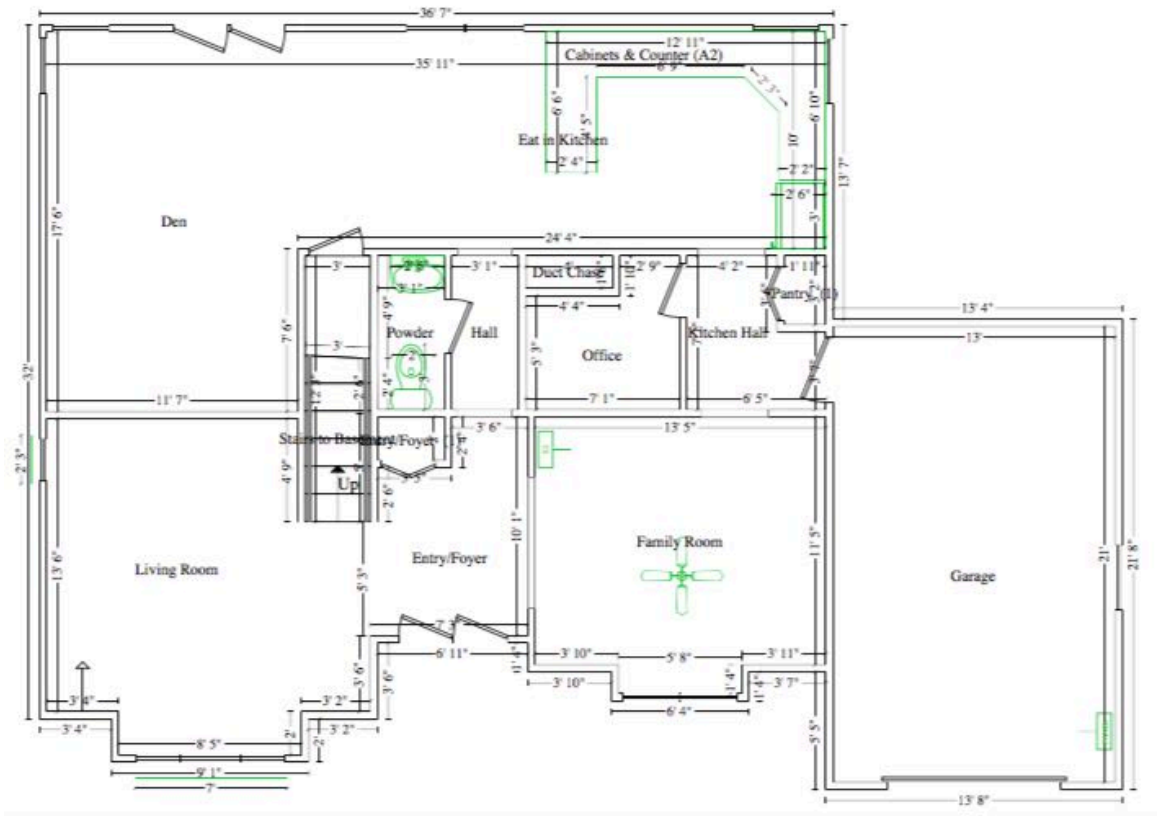
Exhibit 8.4-B

Individual room total = 1,304.55 sf.

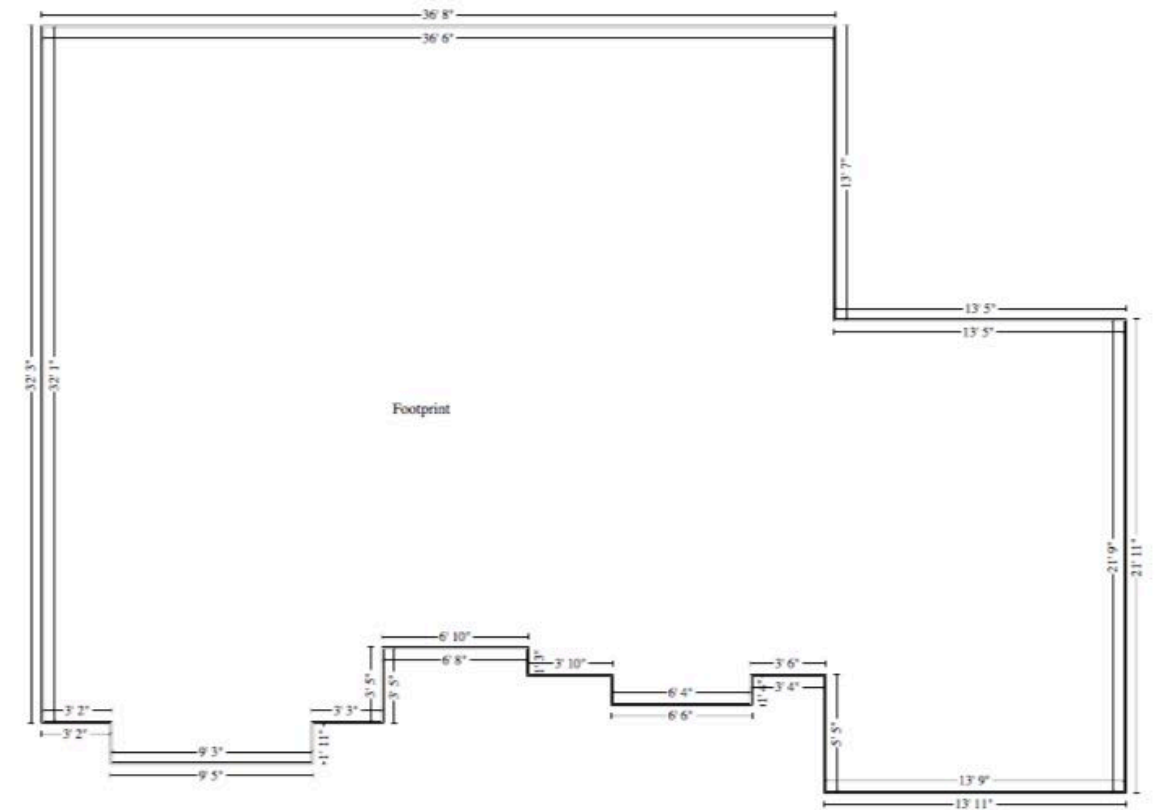
Exhibit 8.4-C

Footprint total = 1,438.18 sf.

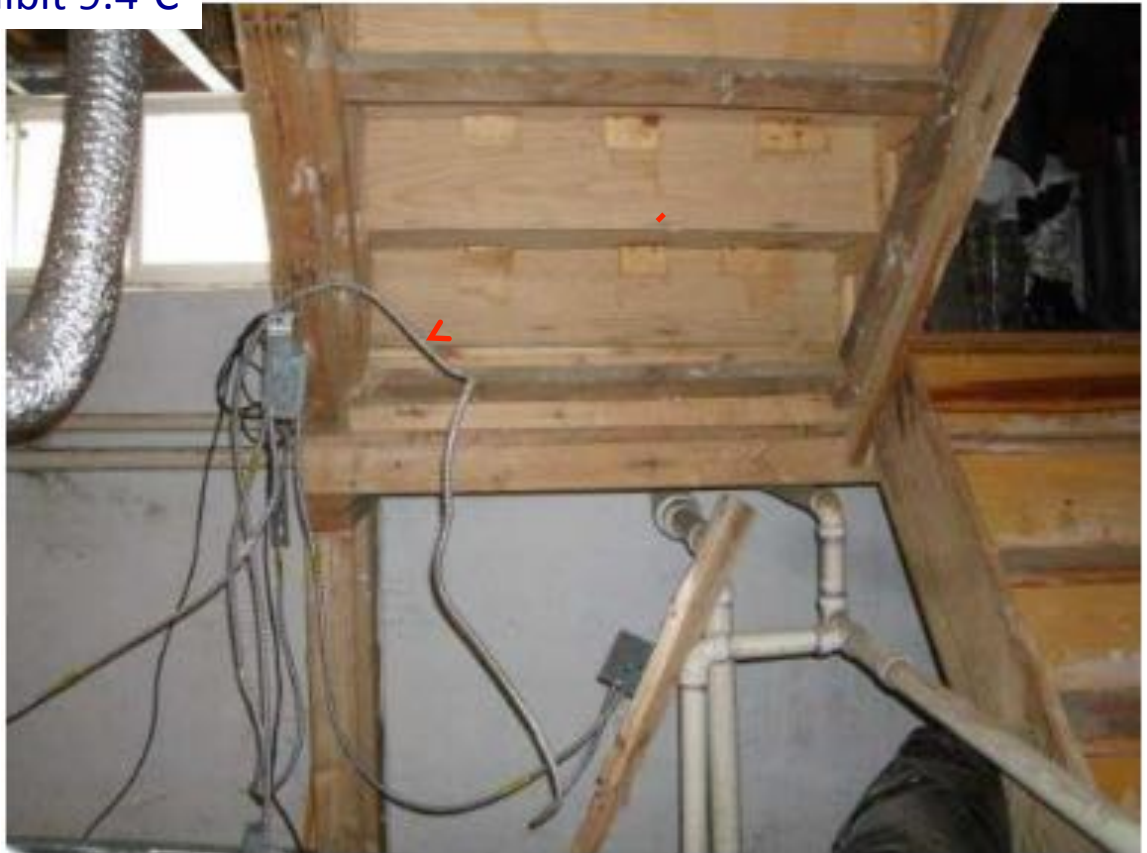
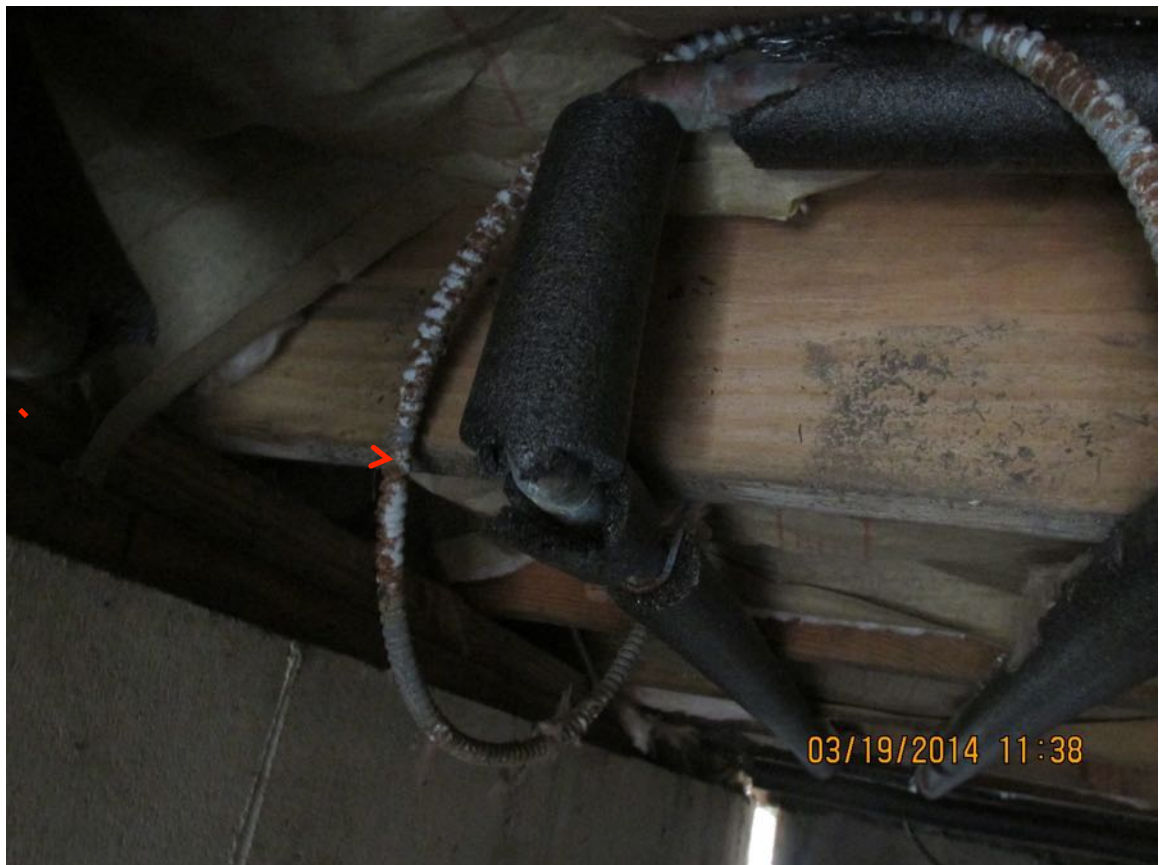
Exhibit 9.4-C

- 9.4-A** Photos – Depicting Romex and BX wiring and their material costs at Home Depot.
- 9.4-B** Photos – Depicting Romex and BX boxes and their material costs at Home Depot.
- 9.4-C** Photos – From Sandy damaged homes showing the presence of BX wiring and metal boxes.
- 9.4-D** Excerpt from Xactimate example – Showing the differences in un-factored unit cost for rewire with and without conduit.
